# Report from field trip, Ethiopia

Preparation for ADCP testing (14-21.08.2012)

# Rapport nr 12 / 2013

# Report from fieldtrip 14.08 – 21.08 on Awash, Kessie and Bure

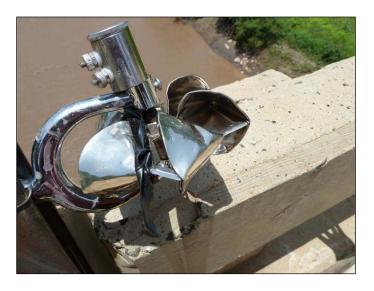
- There is presently only one current meter at each station. Three or four is needed to reduce the risk of having to abort measurements if the current meter is damaged during a measurement.
- The Price Current meters are in bad condition, with cups partly damaged and temporary repairs that possibly affect the calibration of the instruments. The cups are made of a soft material (brass?) and are easily damaged by the high sediment concentrations in the river.
- Recommendations: Check with the producer of the Price meter if it is possible to buy just the cups and if they can be delivered in material that is more solid(e.g., stainless steel).
- Crane and motor needs reconditioning

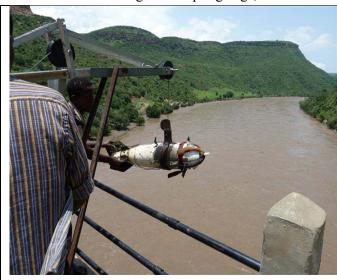
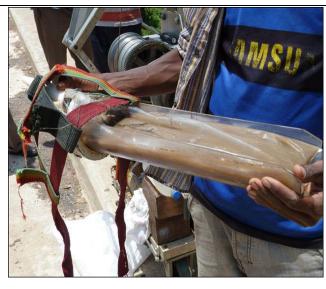
- Generally there should be two sediment samplers at each station
- At Kessie they have only one and the condition of the sampler is very bad.
- At Bure they also have only one sampler. The condition is bad but slightly better than at Kessie
- There is shortage of sampling bags, mouth holder and mouths

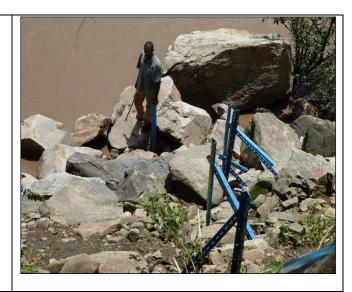
- At Bure the staff gauge has been extended up to 19 m, but water level as high as 23 m has been observed and it is necessary to extend the staff gauge further to cover the total range of water level variation.
- At Kessie a low flow staff gauge is located on the right bank. When the water level exceeds 4m, readings are made from a staff gauge on the bridge pillar at the left bank. This staff gauge is planned to be moved to the right bank and located together with the low flow scale.

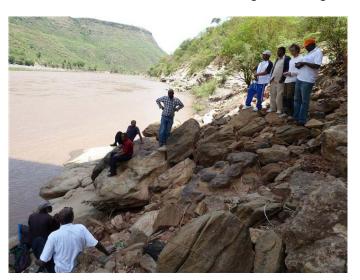
- At Kessie the pressure sensor should be located at the right bank close to the low level staff gauge.
   Weekly reading of the staff gauge should be continued after the pressure sensor installation for control and adjustment of the sensor recordings. For good control readings the high level staff gauge has to be moved to the same location.
- At Bure the best location for installation of the pressure sensor is by the staff gauge.
- The pressure sensors at both stations will be installed during the coming low flow season(2013)
