EXPERIENCES AND FINAL REPORT FROM THE IMPLEMENTATION OF MANTSONYANE AND SEMONKONG SMALL HYDRO ELECTRIC SCHEMES IN LESOTHO

Title <i>Experiences and Final Report from the Implementation of Mantsonyane and Semonkong Small Hydro Electric Schemes in Lesotho.</i>	No 6-91
Executive Officer(s) Ove Rusten (NORPLAN) Per Bang Rolfsen (NOREMCO) Torodd Jensen (NVE) Steinar Grongstad (NVE)	Date June 1991

MANTSONYANE AND SEMONKONG HYDROPOWER PROJECTS

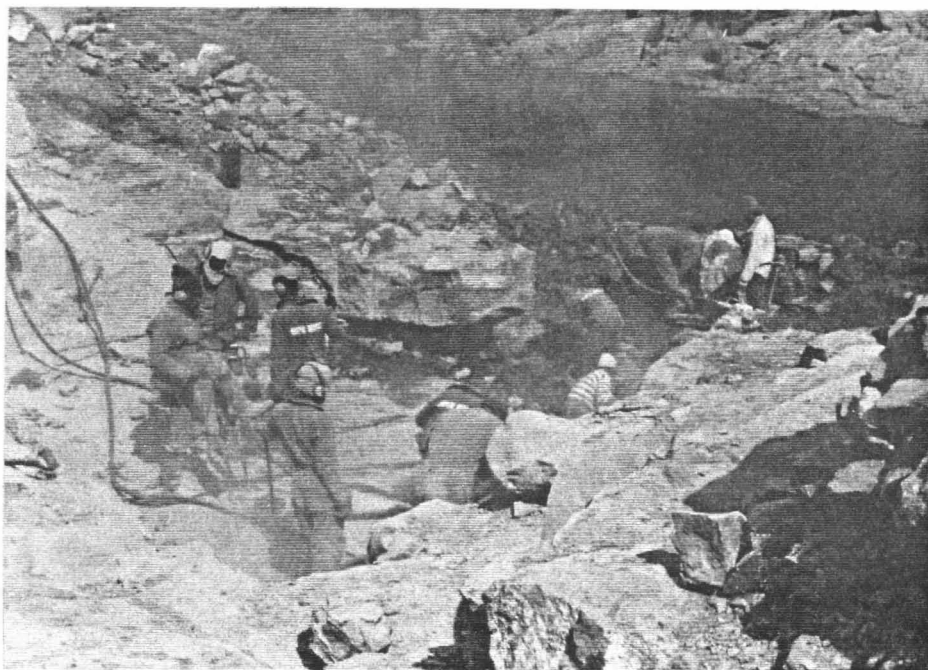
Excavation for the power station, September 1986

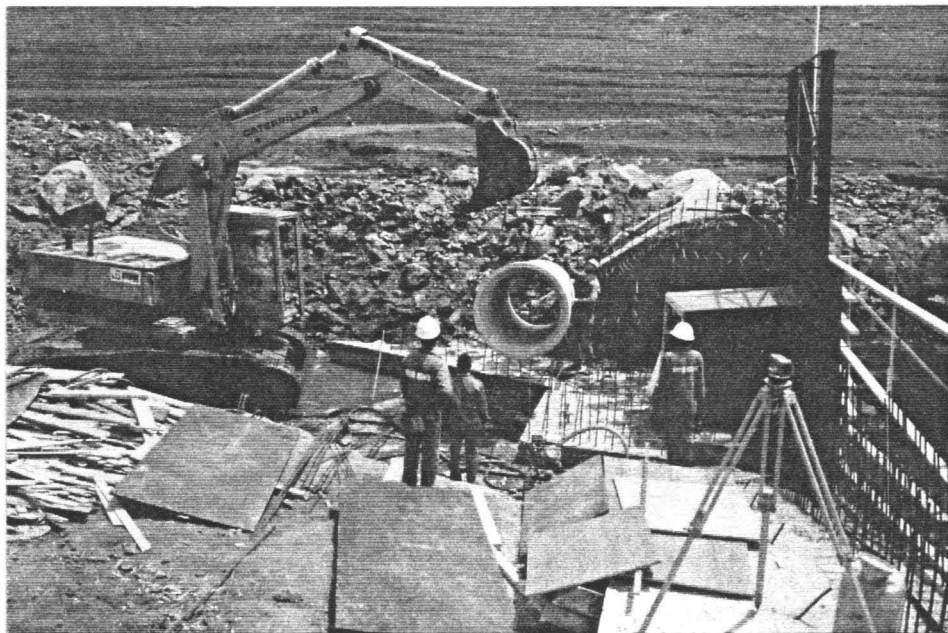
Erection of first pipe section at intake, December 1986

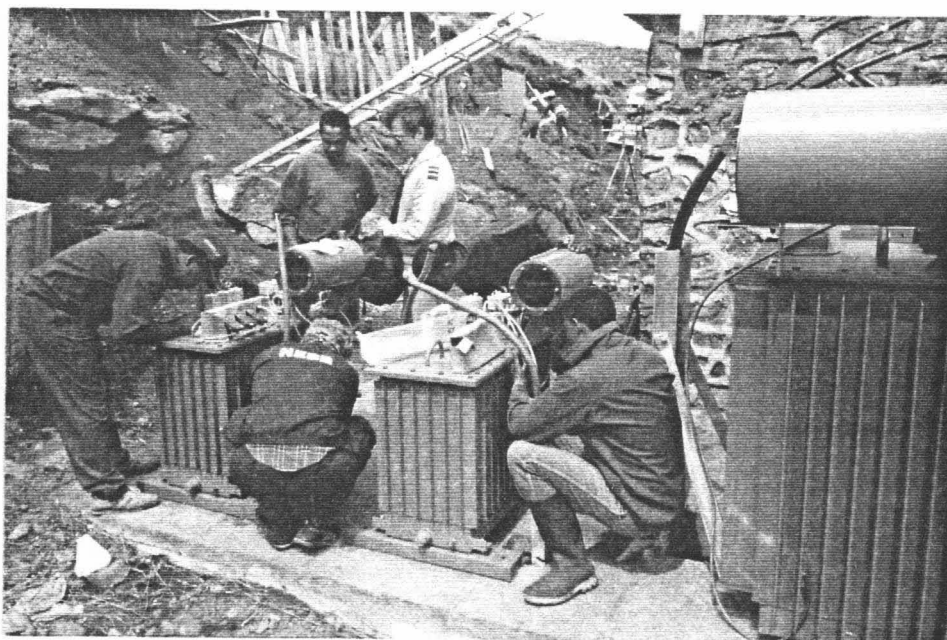
Connection of transformers, November 1987

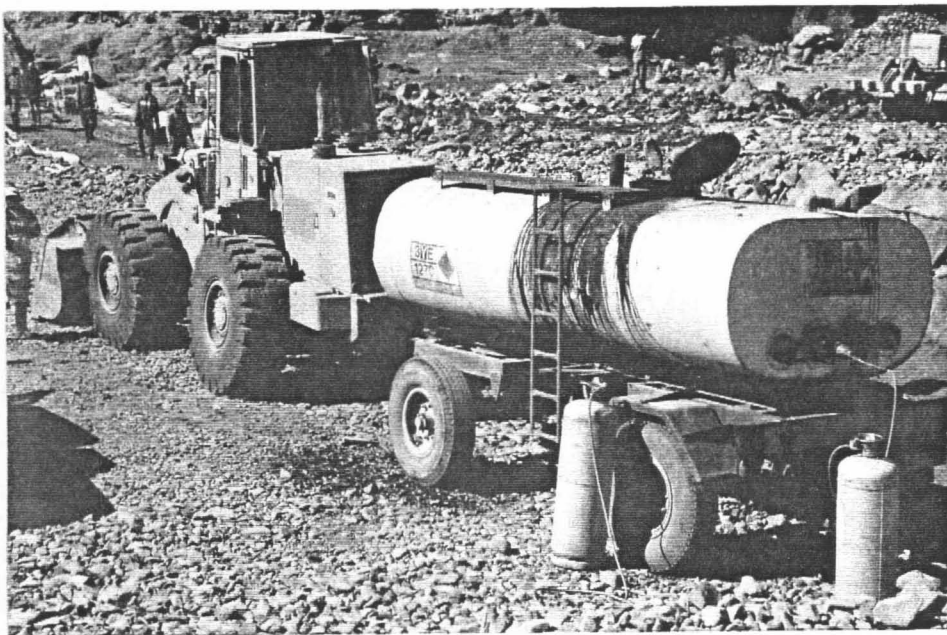
Tank for pouring
at dam site

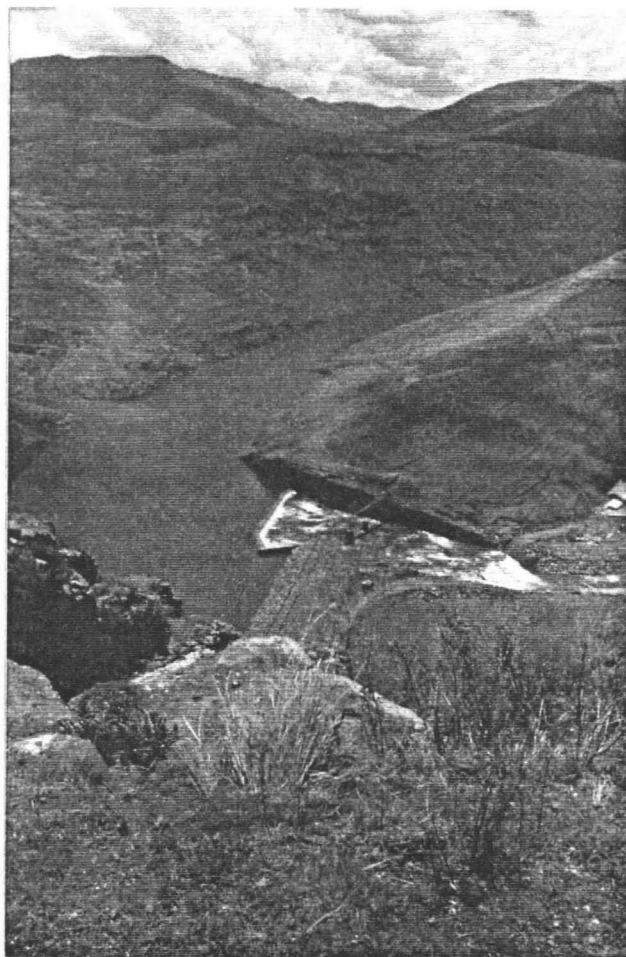
Complete dam and spillway, November 1988
