Fyllingsdammer – nedstrøms plastring og damtå Rockfill dams – downstream riprap and dam toe

FoU-projekt 80409
NTNU

NVE Ekstern rapport nr. 17/2021
Fyllingsdammer – nedstrøms plastring og damtå
Rockfill dams – downstream riprap and dam toe : FoU-project 80409

Published by: Norwegian Water Resources and Energy Directorate
Authors: Ganesh H.R. Ravindra and Fjóla G. Sigtryggisdóttir/NTNU
Cover photo: Ganesh H.R. Ravindra
ISBN: 978-82-410-2162-6
ISSN: 2535-8235
Case number: 201914006

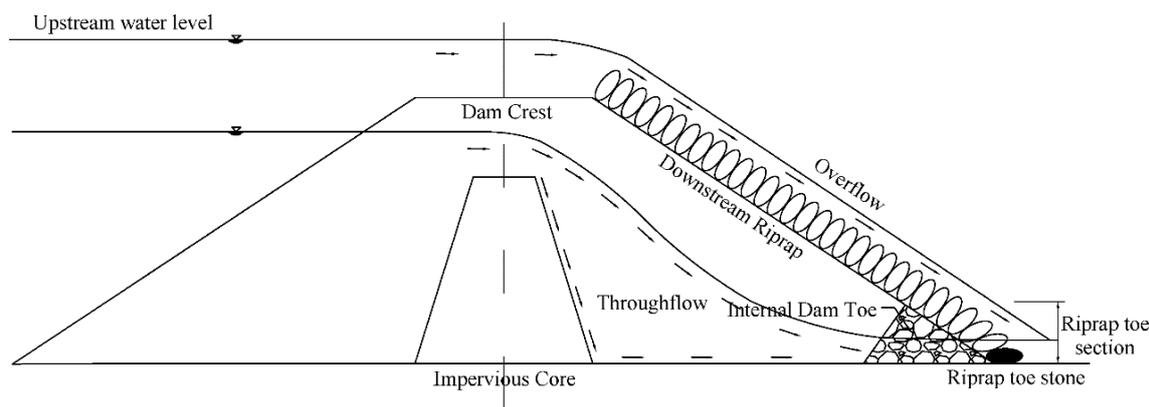
Figure 1. Description of throughflow and overflow scenarios in rockfill dams (Adopted from Ravindra et al. (2019a)).

Under overtopping conditions, the downstream slope of a rockfill dam is subjected to highly destabilizing dynamic forces generated due to turbulent throughflow (overtopping of dam core) and or overflow (overtopping of dam crest). Considering throughflow conditions, turbulent flow with high seepage velocities within the embankment structure can result in internal erosion and also destabilize the downstream embankment due to pore pressure build up (Figure 1). Further, under overflow conditions, the downstream slope is inundated with highly turbulent surface flow resulting in pregressive external erosion leading to dam breach.

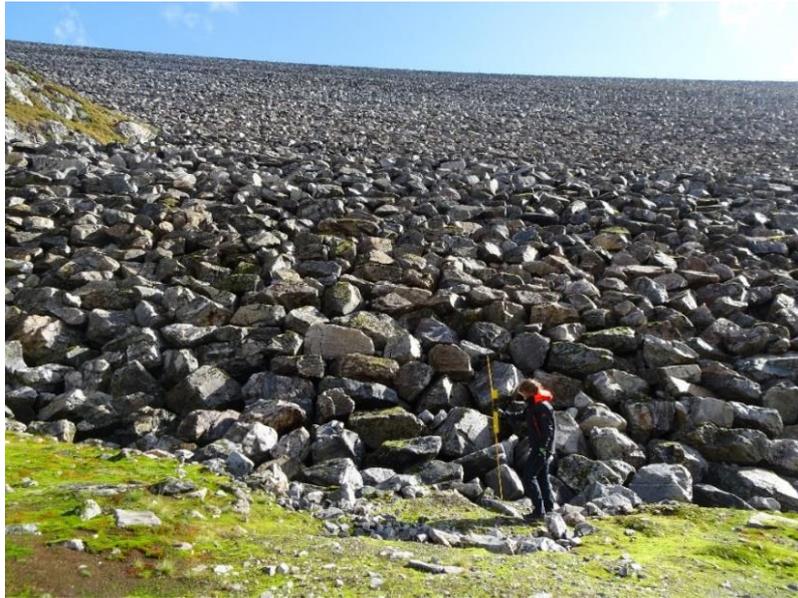
Figure 2. Placed riprap constructed on the downstream slope of dam Oddatjørn, which is a 142 m high rockfill dam constructed in Suldal, Norway (Photo: GHR Ravindra, NTNU).

Ripraps are one of the most widely used erosion protection measures for various in-stream hydraulic structures such as embankment dams, spillways, streambeds, river banks, bridge piers and abutments (e.g. Hiller et al., 2019; Thornton et al., 2014; Abt et al., 2013; Khan & Ahmad, 2011; Siebel, 2007). Ripraps are also used in coastal protection structures such as dikes, embankments and jetties against wave action (Kobayashi & Jacobs, 1985). As applied to rockfill dam engineering, ripraps are constructed on the upstream embankment to protect against erosion resulting because of wave impacts and ice induced forces. Further, ripraps constructed on the downstream slope to protect against erosion due to accidental leakage or overtopping events (Figure 2).

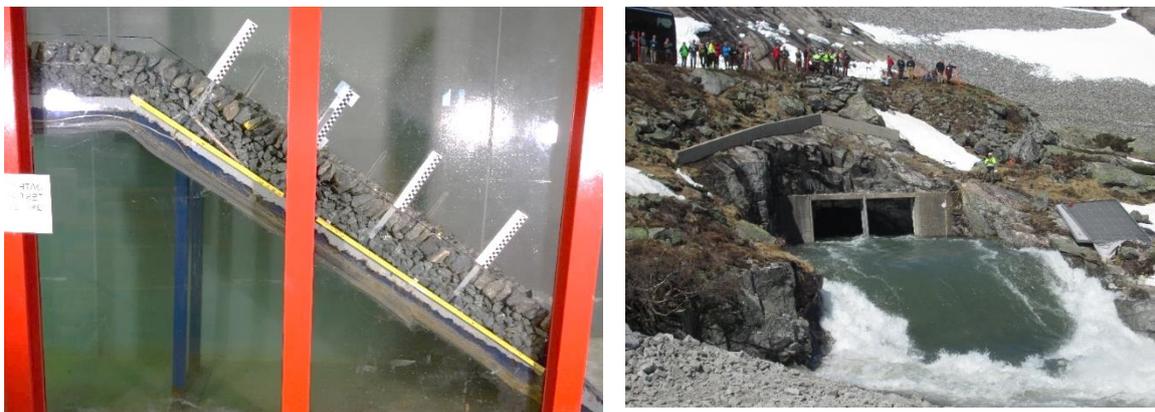
Figure 3. (Left) Sideview of the model setup in the laboratory with placed riprap (Photo: NTNU). (Right) Test with full-scale riprap stones in 2015 (in the Stavanger ICOLD Congress Technical tour).

vertical to the horizontal slope dimensions). Larsen et al. (1986) found that the successive overtopping of the riprap with increasing discharges resulted in a compaction of the downstream part of the placed riprap (Hiller et al., 2018). A new technique for quantification of the compaction process along the chute length was introduced by Larsen et al. (1986) wherein relative stone displacements were monitored as a function of overtopping magnitude. Relative displacements ($\Delta x L_i^{-1}$) of select riprap stones were computed as the ratio of stone displacements along the flow direction (Δx) and the distance between the select stone and the downstream fixed toe structure (L_i). A similar study was later carried out by Sommer (1997) on placed riprap models constructed on slopes $S = 0.25$ to 0.50 . Based on experimental test results, a three step design methodology for placed ripraps was developed by Sommer (1997) taking into account stone displacements. Further, the recent study conducted by Hiller et al. (2018) adopted the technique of relative stone displacement monitoring to analyse the 1D failure mechanism in placed ripraps with fixed toe supports constructed on steep slopes of $S = 0.67$. Hiller et al. (2018) (Figure 3 left) concluded that unidirectional stone displacements along the chute direction leading to formation of a gap at the upstream section of the riprap was the underlying 1D failure mechanism in placed riprap supported at the toe. Further, to evaluate laboratory and scaling effects and for further validation of the physical modeling test results, overtopping tests on placed and dumped ripraps at prototype scale were conducted by (Hiller et al., 2019) (Figure 3 right).

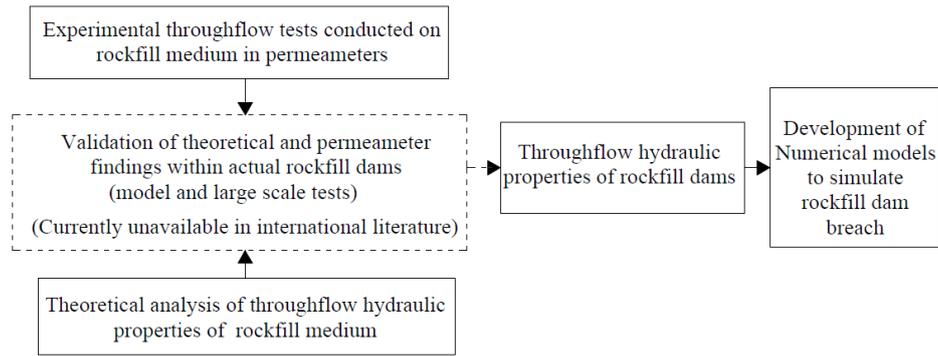
Figure 4. Illustration of processes involved in the development of a numerical rockfill dam breach model and the missing link currently unavailable in international literature (Adopted from Ravindra et al. (2019b)).

Although these different permeameter studies have provided valuable insight into throughflow hydraulics in rockfill material, research into quantitative physical validation of these relationships in actual rockfill dams is currently unavailable in international literature. This is considering the fact that any findings originating from theoretical studies or from experimental investigations conducted in permeameters inevitably require validation within actual rockfill dam models at laboratory and large scales to enhance confidence in the findings for practical implementation. This has been a missing link in the process of development of a sophisticated numerical model simulating rockfill dam breach (Figure 4).

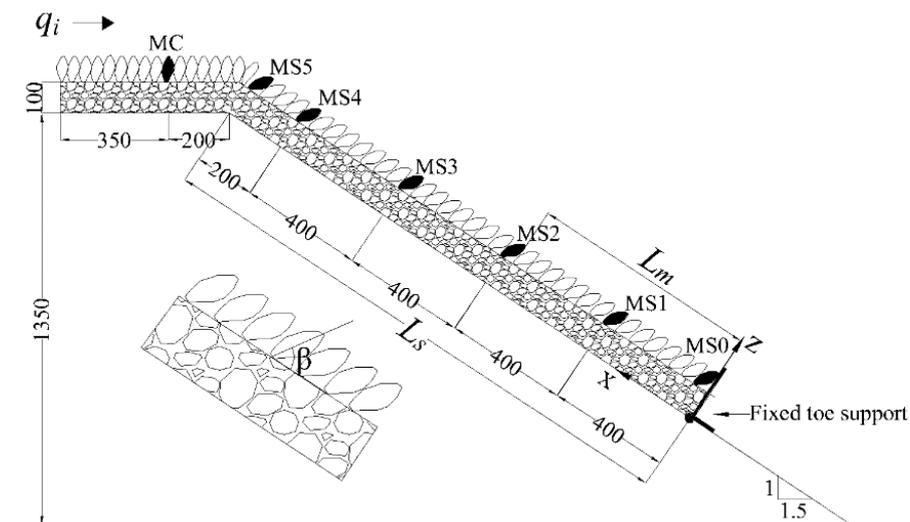
Figure 6. Depiction of experimental setup of model placed riprap supported at the toe. This depiction of the experimental setup is a modified form of Figure 3 from Hiller et al. (2018).

Placed ripraps were constructed by manual placement of stones in an interlocking pattern commencing at the toe progressing upstream to the crest. The test setup required 1200 stones on average. Riprap stones on the slope were deliberately placed with the longest axis (a -axis) inclined at $\beta \approx 60^\circ$ with respect to the chute bottom and with an inclination of $\beta \approx 90^\circ$ for stones placed on the horizontal crest to account for practical considerations (Figure 6) (Lia et al., 2013). The ripraps were supported at the toe section with a metallic support structure and the entire test setup was elevated from the flume bottom to avoid backwater effects (Figure 5). The experimental setup was situated sufficiently downstream of the inflow section to achieve calm flow upstream of the test ripraps.

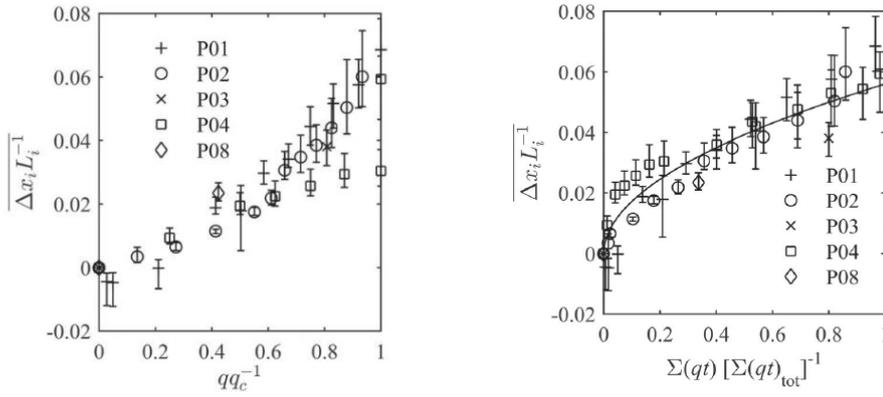
Figure 7: (Left) Averaged dimensionless displacements over MS0 to MS1400 compared to the relative discharge and (Right) compared to the volume of water passed over the riprap, Hiller et.al. (2018)

where N is the amount of stones per m^2 , influence the stone displacements and in turn stability of placed ripraps. Lower values for chute length and packing factors resulted in stability gain for the placed ripraps.

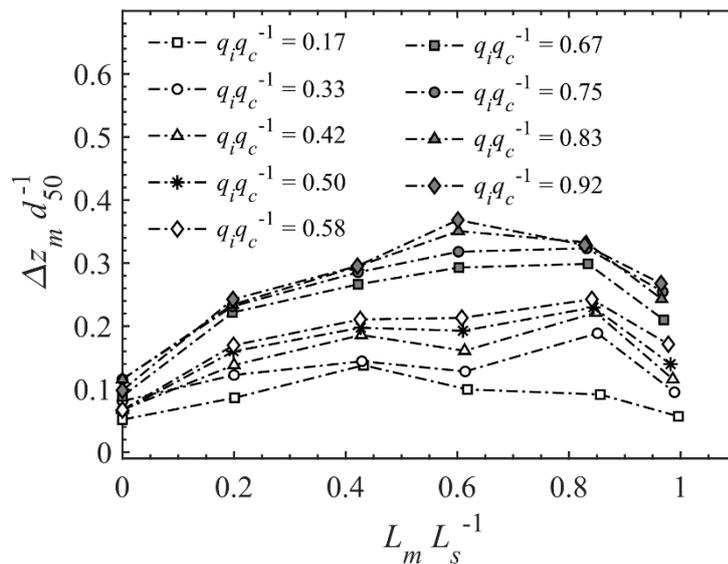
Figure 8. Depiction of 2D displacements of selected riprap stones for test 1 from Table 5 (Adopted from Ravindra et al., 2020a).

Figure 8 illustrates 2D displacements analysis results from a single test, test 1 presented in Table 4. The plot depicts development of 2D stone displacements as a function of applied overtopping discharge magnitudes ($q_i q_c^{-1}$). The horizontal axis of the plot ($L_m L_s^{-1}$) represents the distance to the respective selected riprap stones from the riprap stone placed adjacent to the fixed toe structure along the x -axis ($L_m = x_m - x_0$) (Figure 6) normalized over the total riprap length ($L_s = x_5 - x_0$ at $q_i q_c^{-1} = 0$). Stone displacements were computed with respect to the position of selected riprap stone adjacent to the fixed toe structure as the displacement of the stone identified as MS0 were moderate in comparison with the displacements measured for the other stones. The vertical axis of the plot represents the progressive stone displacements along the z -axis normalized over the median riprap stone diameter ($\Delta z_m d_{50}^{-1}$).

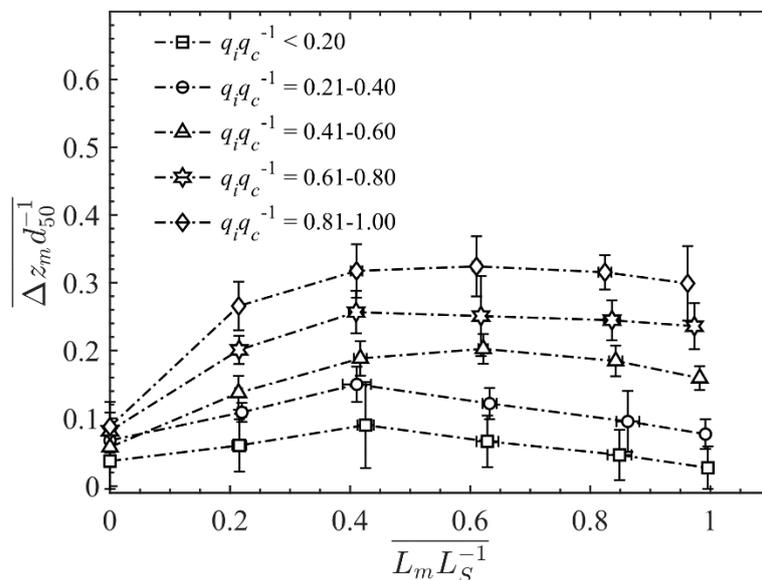
Figure 9: Results from the cumulative analysis carried out on data sets from seven tests representing average stone displacements in 2D. Uncertainty in displacements shown as 95% confidence intervals (Adopted from Ravindra et al., 2020a).

Figure 9 presents results from the cumulative statistical analysis carried out with data sets obtained from all the seven tests presented in Table 2. Similar methodology as outlined for test 1 (Figure 8) has been adopted to compute the 2D stone displacements for the remainder of the tests. Figure 8 depicts the mean trends of 2D stone displacements for all the tests represented by average values of $\Delta z_m d_{50}^{-1}$ and $L_m L_s^{-1}$ computed for the seven tests at uniform intervals of overtopping ($q_i q_c^{-1} = 0.20$). Variability in test results are presented as 95% confidence intervals.

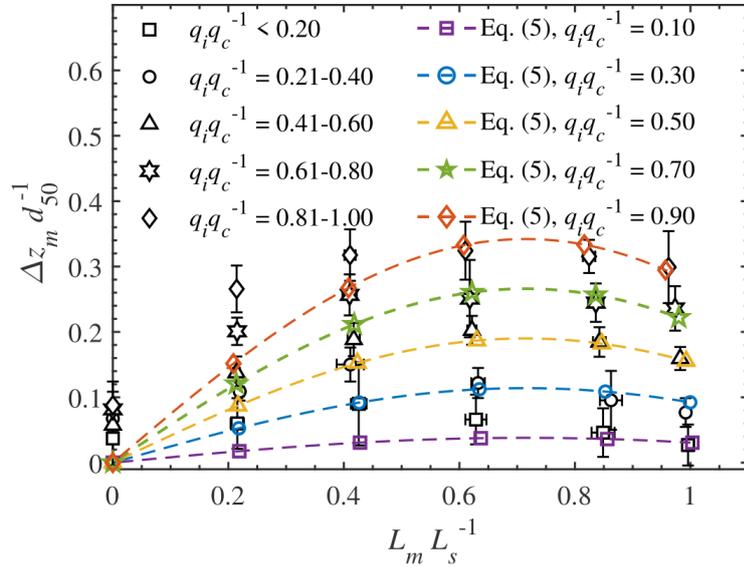
Figure 10. Observed 2D stone displacements from Figure 9 juxtaposed with predicted values from Equation 13 (Adopted from Ravindra et al., 2020a).

between the observed and the predicted displacements of $R^2 = 0.89$ and $R^2 = 0.99$ for $\Delta z_m d_{50}^{-1}$ and $L_m L_s^{-1}$ respectively. Further, Equation 13 with $A = 0.38$, $f = 0.70$ and $k = 1$, was used to compute the continuous profiles of the buckling progression also presented in Figure 10.

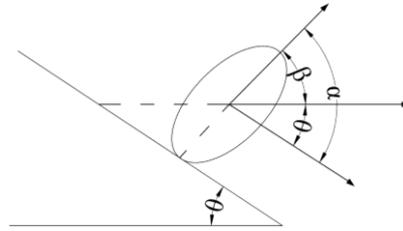
Figure 11. Portrayal of stone inclination with respect to the dam slope (α) as sum of inclination with respect to the horizontal (β) and embankment slope (θ) (Ravindra et al., 2019a).

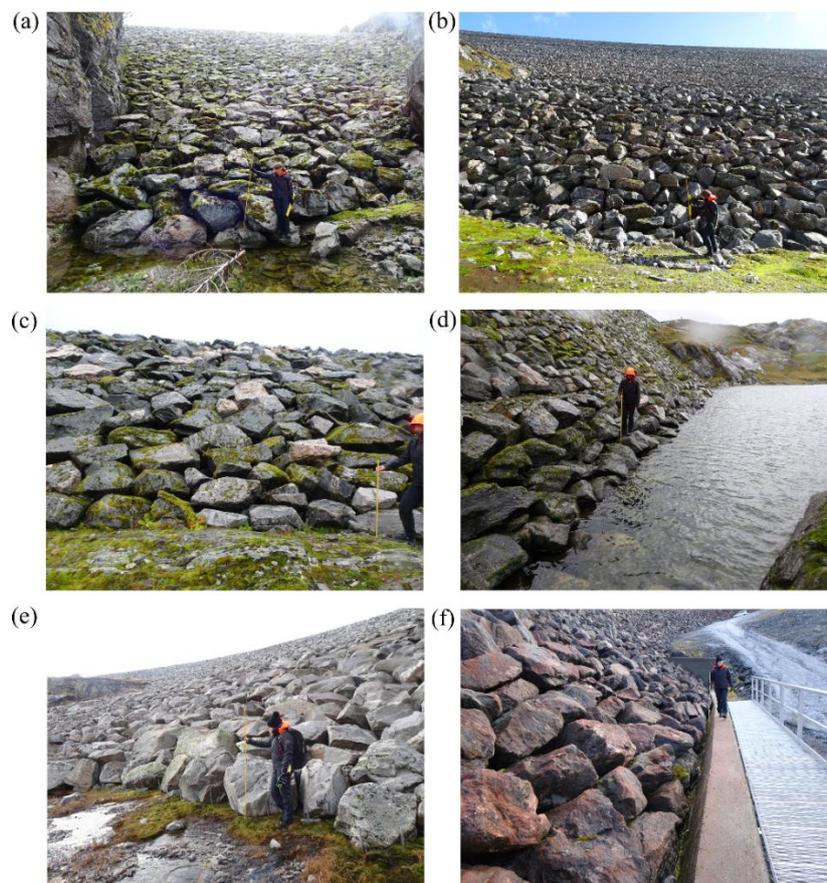
Figure 12. Depiction of existing conditions of placed riprap toe sections. Category 1 at dams (a) Fjellhaugvatn dam (b) Oddatjørn dam and (c) Skjerjevatnet main dam. Category 2 at (d) Skjerjevatnet main dam. Category 4 at (e) Storvass dam. Category 5 at (f) Akersvass dam (Adopted from Ravindra et al., 2019a).

Category	Description of toe condition	Dam name
1	No toe support	All surveyed dams (Table 2)
2	Submerged toe	Skjerjevatnet main dam Skjerjevatnet secondary dam 1 (e.g. Figure 15(d))
3	Larger stones at the toe	Fjellhaugvatn dam Storvass dam (Figures 15(a) and (e))
4	Steel rebars	Storvass dam (Figure 15(e))
5	Concrete wall	Akersvass dam (Figure 15(f))

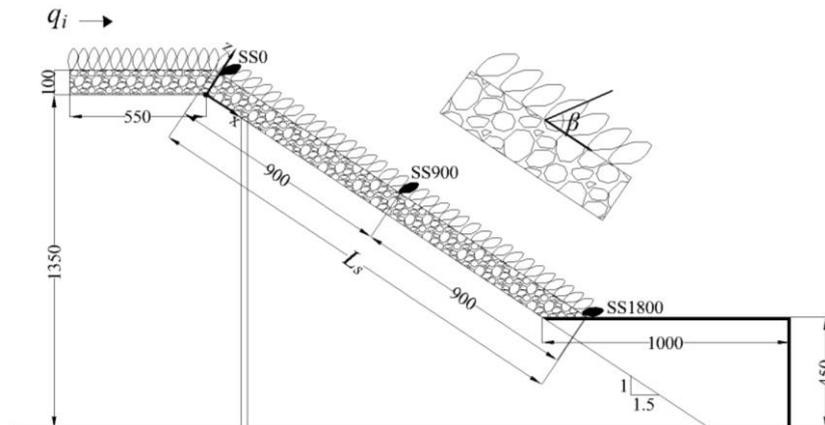
Figure 13. Illustration of experimental setup of model placed riprap with unsupported toe (Adopted from Ravindra et al. (2020b)).

As previously stated, the original model designed by Hiller et al. (2018) consisted of a fixed metallic toe support structure fastened to the base frame at the downstream end of the riprap chute providing resistance against sliding of the riprap structure. A modified version of the model setup was used in the HydroCen study, wherein the fixed toe support structure was replaced with a horizontal platform at the downstream extremity of the riprap chute to facilitate construction of placed riprap models with unrestrained toes (Figure 13). The modifications to the experimental rig were so designed as to maintain the original dimensioning of the riprap structure as employed in the preceding investigations to enable comparison of experimental findings. The surface of the horizontal platform was covered with a layer of geotextile to provide realistic friction for the toe stones.

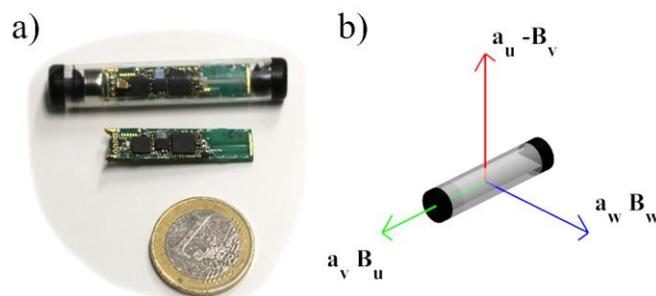
Figure 14. (a) The Smartstone probe in a plastic tube with button cell on the left end and the circuit board with sensors underneath. (b) The probe's coordinate system (Adopted from Ravindra et al. (2020b)).

Smartstone sensors are accelerometers designed to be implanted in stones for tracking of parameters describing stone displacements such as accelerations and rotations in time. The module comprises of a triaxial acceleration sensor, a triaxial gyroscope and a geomagnetic sensor (Figure 14). Owing to their non-intrusive nature of operation and flexibility for applicability in various engineering and research disciplines, Smartstone technology was found to be an ideal technique for implementation within the present experimental program.

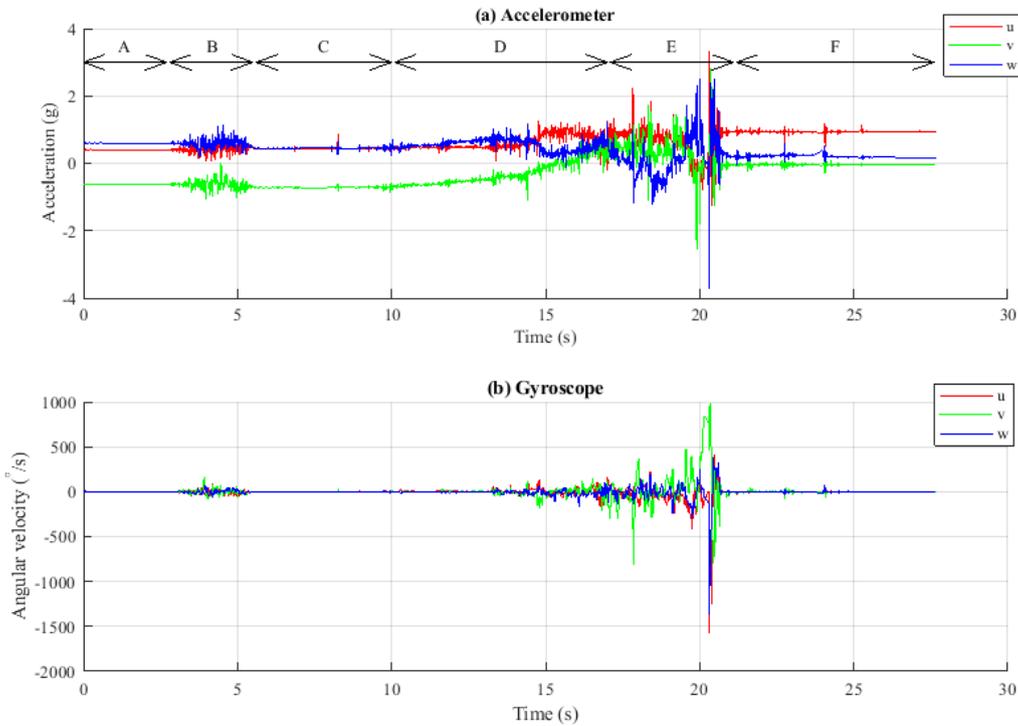
Figure 15. Depictions of (a) accelerometer and (b) gyroscope measurements from the Smartstone placed at the riprap crest (S_0) from test P05 (Ravindra et al., 2020b).

further progressing as total riprap collapse, depictions of stone acceleration and orientation measurements for an overtopping test conducted on a model placed riprap are presented as Figure 15). Recorded measurements from the Smartstone placed at the riprap crest (S_0 from Figure 13) from test P05 are portrayed in Figure 15. Further, the individual phases of stone motions within the time series are labelled with capital letters.

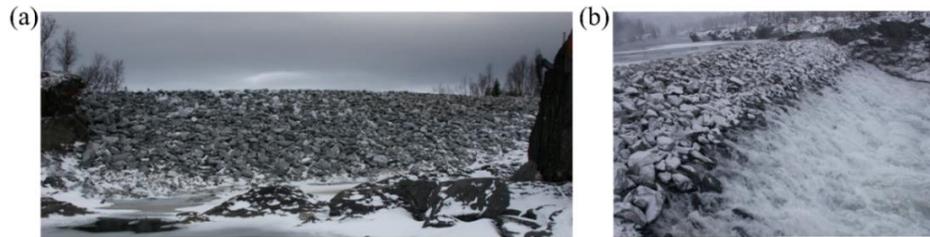
Figure 16. (a) Image of the test rockfill embankment (M1) from the test site downstream of Røssvatn, southern Norway prior to testing; (b) Image of the test dam during testing (Image courtesy: EBL Kompetanse (2006) and published in Ravindra et al., 2019b).

of 4 m along the flow direction for throughflow depth measurements. Images from the test site depicting the test embankment prior to and during testing are presented in Figures 16(a) and 16(b) respectively.

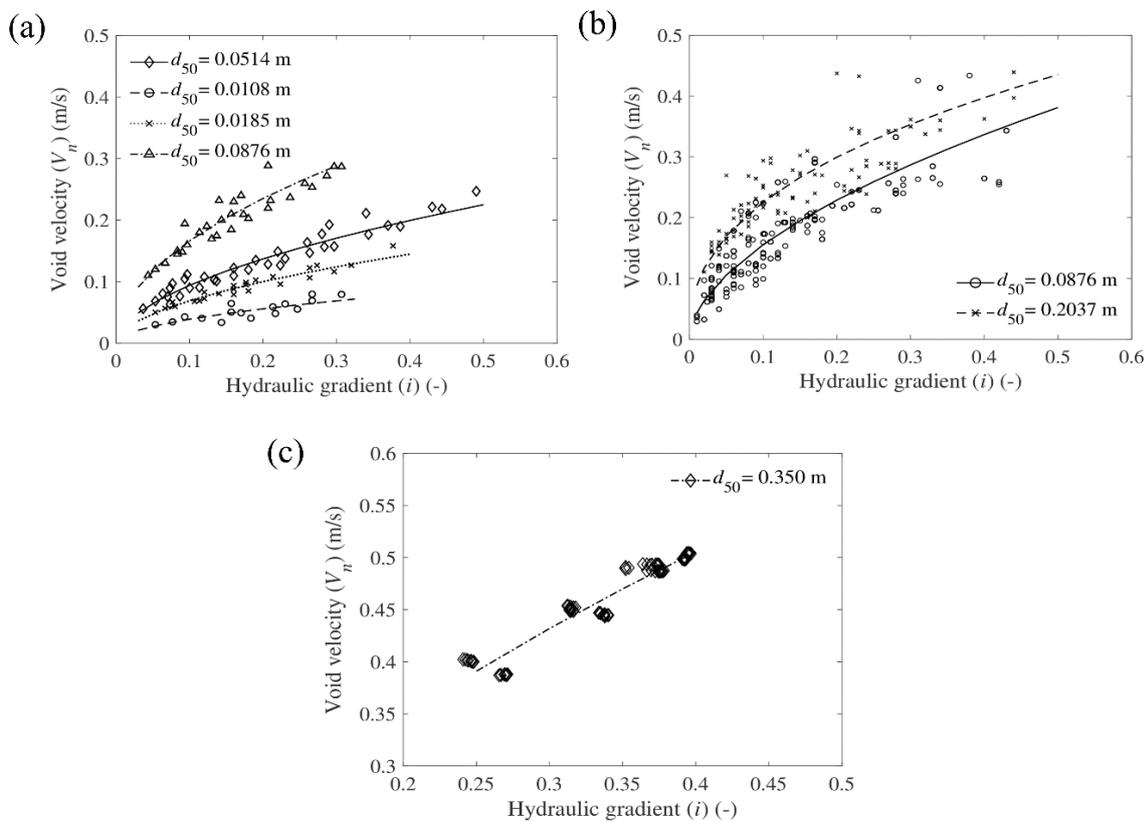
Figure 17. Computed i - V_n trends for (a) 0.6 m high dam model (b) 1.2 m high dam model and (c) 6 m high large-scale dam (Ravindra et al, 2019b).

$b = 0.41$ was found. The average of the obtained b values was found to be $b = 0.51$. As stated earlier, parameter b within the power-law (Equation 5) represents the degree of flow turbulence. The obtained average value of parameter $b = 0.51$ signifies fully developed turbulent flow regime. This finding is in line with conclusions of several past studies such as Escande (1953), Soni et al. (1978) and Siddiqua et al. (2011) with regards to parameter b that $b \approx 0.5$ represents post-linear or non-Darcian flow regime. Furthermore, correlation between material properties such as C_u and n and parameter b were evaluated and no definitive relationships could be observed in this regard between the parameters. Considering the anomalous value of $b = 0.41$ for test 7, although the exact reason for the observation is not apparent, the large size of the rockfill particles used for the test ($d_{50} = 0.203$ m) could offer a possible explanation in this regard as the mean stone diameter for this particular test was oversized considering the dam height ($H = 1.2$ m). This could inhibit complete development of flow turbulence resulting in a lower value of b . Furthermore, the porosity of the dam material for test 7, $n = 0.52$ was slightly higher in comparison with other materials which fall within a range of $0.40 - 0.49$ and this could also influence flow turbulence levels within the test dam.

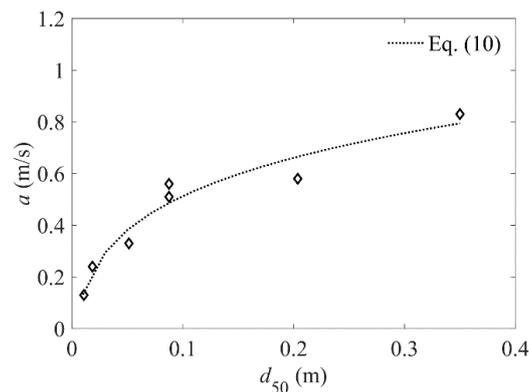
Figure 18. Relationship between parameter a and the mean rockfill particle sizes (d_{50}) (Ravindra et al, 2019b).

$$V_n = \left(72.987 - \frac{73.613}{\left(1 + \left(\frac{d_{50}}{1.136 \cdot 10^9}\right)^{0.179}\right)} \right) i^{0.51} \quad (19)$$

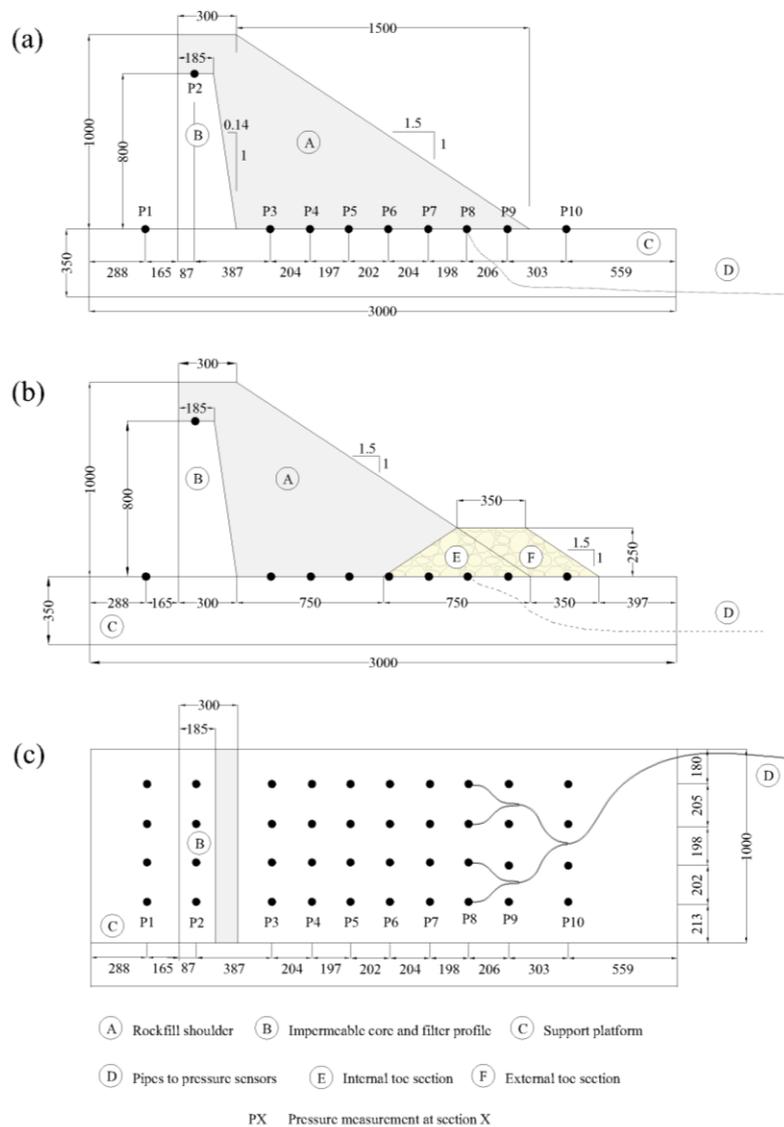
Figure 19. Depictions of the experimental setup with (a) planar view of the horizontal platform (b) sectional view of the rockfill dam model and (c) details regarding the disparate toe configurations.

bottom in order to avoid backwater effects (Figure 19). The experimental setup was situated sufficiently downstream of the inflow section of the flume to achieve calm flow upstream of the test models. A series of 10 pressure sensors (P1-P10) were coupled with the experimental setup for measurements of internal pore pressure developments at different locations within the dam structure as shown in Figure 19(a) and also for monitoring of the upstream/downstream water levels during the overtopping tests. The pressure sensors were connected to the platform through a pipe network linked to an array of holes as depicted in Figure 19(c). A series of four holes were provided along the width of the platform at each pressure measurement location for measurement of the average pressure levels and also as a safety precaution against blockage.

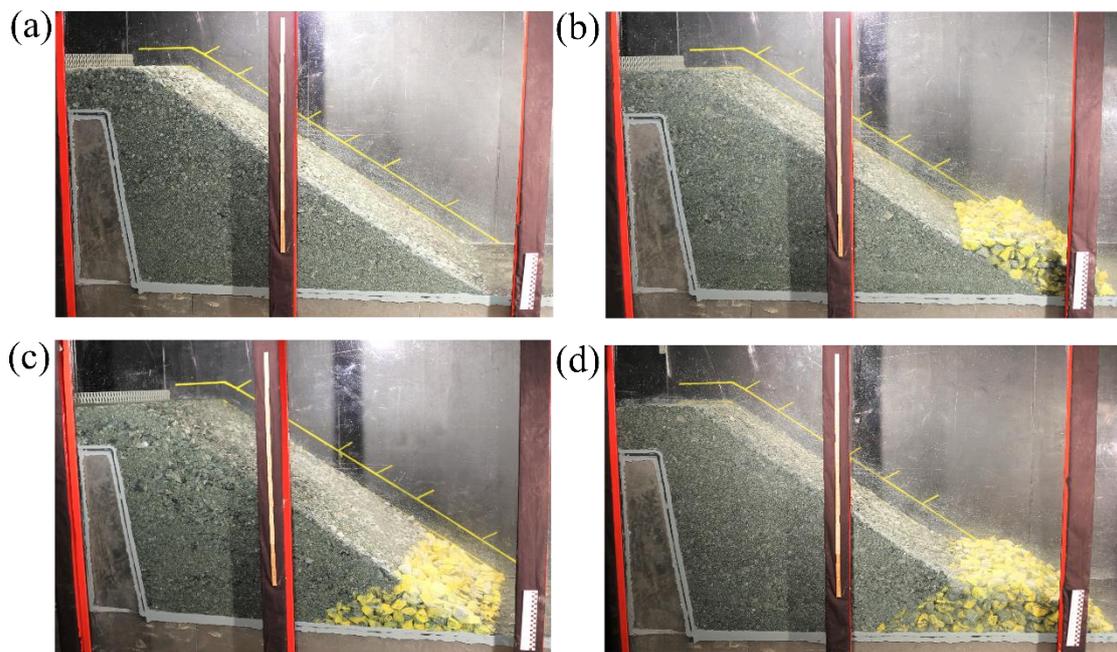
Figure 20. Depictions of the rockfill dams with (a) no toe, (b) external toe, (c) internal toe and (d) combined toe configurations.

The dam shoulder comprised of well-graded rockfill material of density $\rho_S = 2720 \text{ kg m}^{-3}$, median particle size $d_{50,S} = 0.0065 \text{ m}$ and coefficient of uniformity of $C_{u,S} = 7.5$. The toe sections were constructed employing uniformly graded coarse rockfill of density $\rho_T = 2860 \text{ kg m}^{-3}$, median stone size $d_{50,T} = 0.052 \text{ m}$ and coefficient of uniformity $C_{u,T} = 1.42$. The material gradations were scaled down from a data base of gradation curves from large-scale rockfill dam constructions with a scaling ratio of 1:10. However, the gradation was biased towards the coarser range of the database. This was due to restrictions with the pumping systems installed in the laboratory, inclusion of very fine particles $< 0.5 \text{ mm}$ was not possible in the model. Hence, the gradation was carried out with 0.5 mm as the minimum allowed particle size.

As described previously, pore pressures were measured at different locations within the dam structures (P2-P10) during the tests (Figure 20). In addition, the corresponding upstream water levels (P1) were recorded. The raw pore pressure datasets were subjected to a change point based statistical analysis to obtain representative pore pressure magnitudes at different discharge levels (q_i). The pore-pressure development patterns at different locations within the dam structure for Test 1 conducted with no toe (Table 8) are depicted in Figure 21. The pore pressure values depicted for each of the discharge intervals represent the stable values attained after maintaining the discharge magnitude at the respective levels over time periods of $\Delta t = 1800$ s. As can be observed, the individual pore-pressure levels within the rockfill shoulder were found to undergo non-linear increments as functions of the applied throughflow magnitudes for Test 1. The non-linear trends in pore-pressure developments were found to be less pronounced at the downstream section of the dam structure. Similar trends were observed for all the tests.

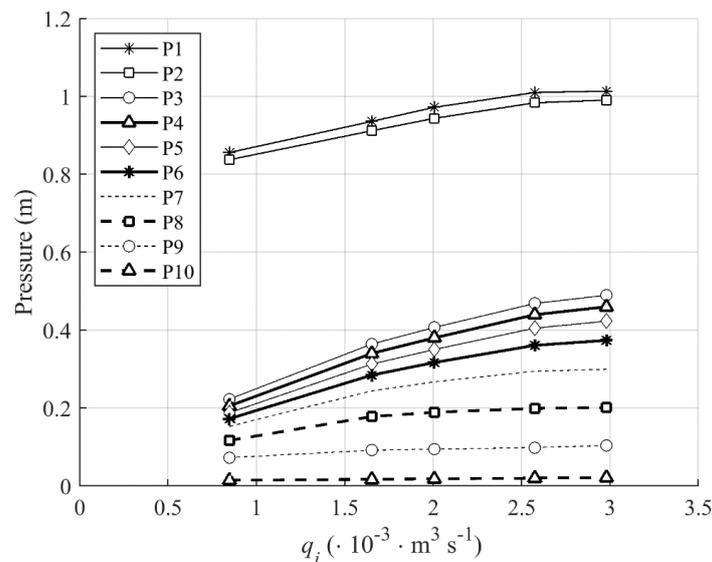
Figure 21. Pore pressure development profiles at different locations within the dam structure for Test 1 from Table 8.

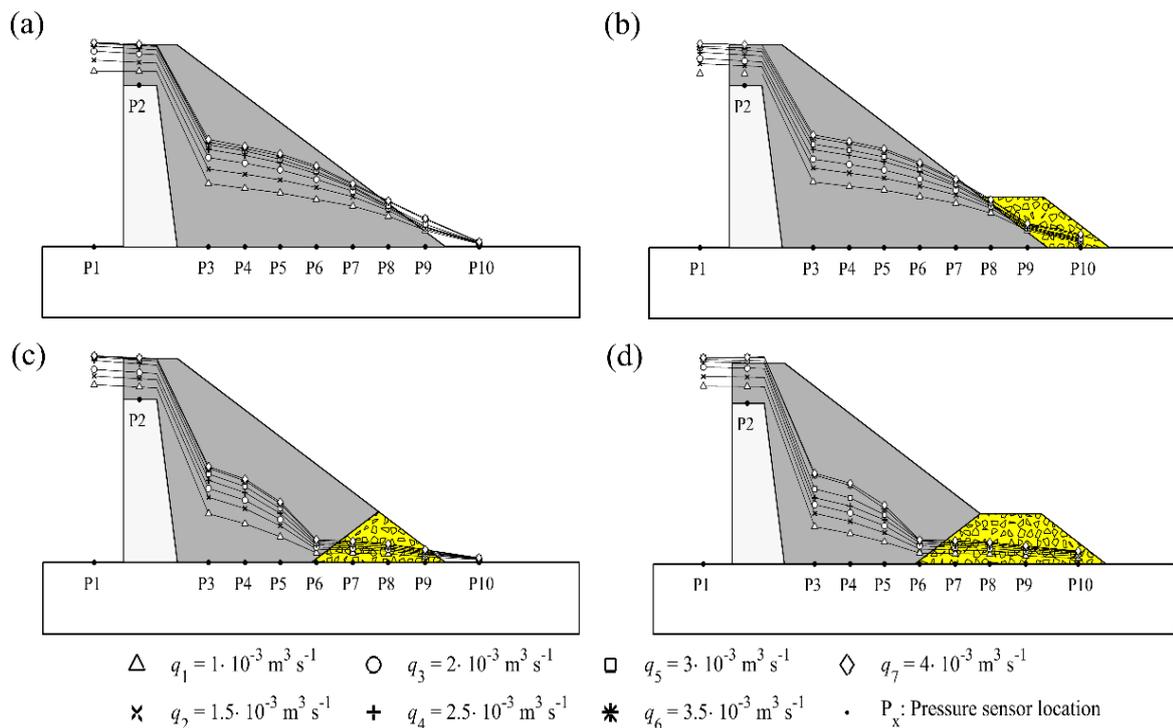
Figure 22. Phreatic surface depictions within model rockfill dams with (a) No toe, (b) external toe, (c) internal toe and (d) combined toe configurations as functions of applied throughflow magnitudes (q_i).

The effects of different toe geometries on phreatic surface developments within the rockfill dam structures were investigated. Figure 22 depicts the positions of the phreatic surfaces within the model dams coupled with different toe configuration as derived from pore pressures measured at the ten pressure sensor locations (P1-P10, Figure 20). As can be observed from Figure 22, the flow patterns upstream of sensor location P3 were found to be consistent across models. During the tests, the water surface profiles upstream of the dam crest section (P1) were observed to be horizontal in nature as they entered the crest. Hence in Figure 22, the water surface profiles are shown as extensions of pressure measurements from P1 onto the entry surface of the crest using horizontal lines. Further, the drops in pressure from the entry location to P2 were used to plot flow lines with mild gradients over the core-filter element. Furthermore, the flow underwent transitions over the core-filter element and in turn plunged into the downstream dam structure towards P3. The plunge patterns were visually observed to be near vertical drops. This could be explained as a consequence of the steep slope of the core-filter element. A milder slope would lead to more moderate flow patterns.

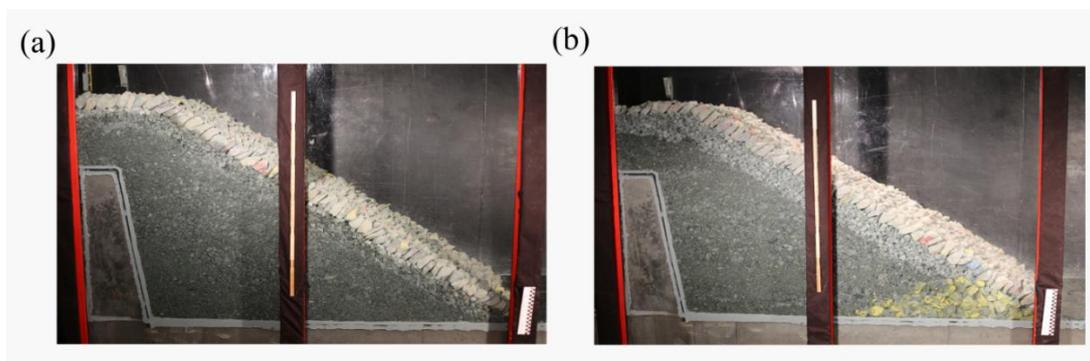
Figure 23. Rockfill dam model coupled with (a) riprap on the downstream slope and (b) with riprap and internal dam toe section.

Rockfill dam model presented as M3 (Figures 19 and 20) was further used as part of M4. For the model setup M4-A, the 1.8 m long downstream slope of the downstream dam slope was used for construction of riprap with unrestrained toes (Figure 23 (a)). The same riprap stones as used within M1 and M2 were further utilized. For the construction of riprap with unrestrained toes, the methodology detailed within Section 5.3 for M2 was further adopted. The riprap model was built on a 0.1 m thick filter layer following the norm adopted within M1 and M2. The filter sections uniformly graded coarse rockfill of density $\rho_F = 2900 \text{ kg m}^{-3}$, median stone size $d_{50,F} = 0.022 \text{ m}$ with coefficient of uniformity $C_{u,F} = 1.2$.

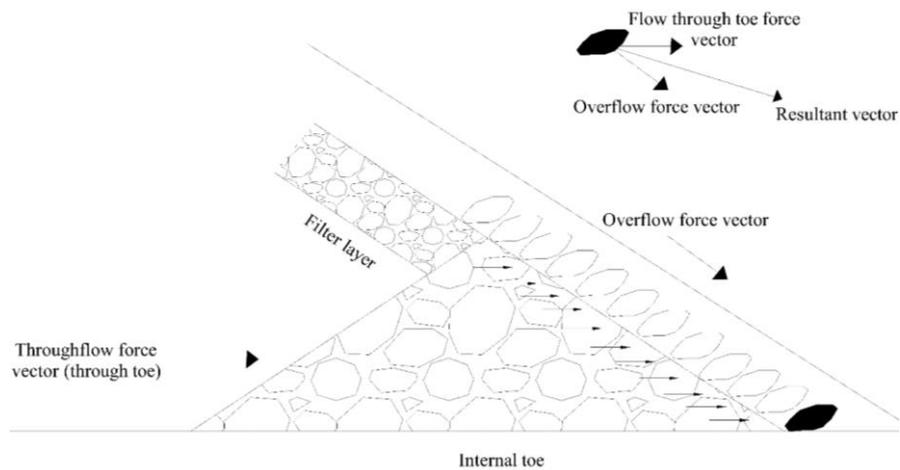
Figure 24. Flow force vectors depiction.

Further, due to the coarse nature of the material used for the construction of the internal toe, the exit throughflow would have much higher velocities as compared to a dam without internal toe. This could lead to crossing of high velocity flow velocity vectors between the exit throughflow forces and the overflow forces leading to attenuation of flow forces and in turn, lower degree of resultant forces on the riprap toe stones (Figure 24).

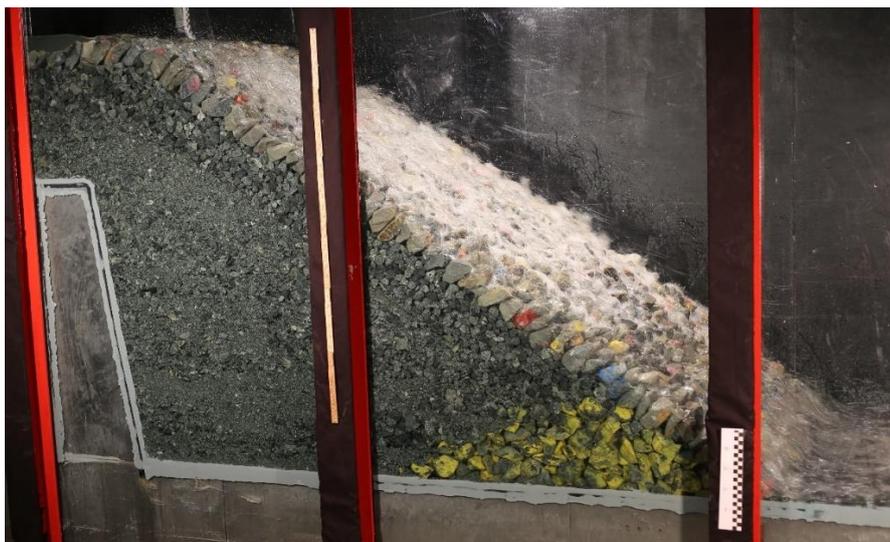
Figure 25. Snapshot from Test 3 (Table 9) depicting overflow.

Although the described effect is challenging to discern visually at high discharges, it is clearly evident at low discharges. Figure 25 presents a snapshot from Test 3 (Table 9). Overflow in the model was generally found to be characterized by white water (highly aerated) flow. As can be seen from Figure 25, the upper reaches of the riprap is covered with aerated flow. However, the flow over the riprap section covering the exit face of the internal toe does not have any white-water flow over it. This can be explained as due to the effect brought to light earlier. The overflow gains high velocities under the influence of gravity as it skims over the riprap. As the flow reaches the toe section, the flow vector is disrupted by the throughflow vector exiting the toe section which leads to rapid reductions in the flow velocities and in turn, flow forces on the riprap stones at the toe section.

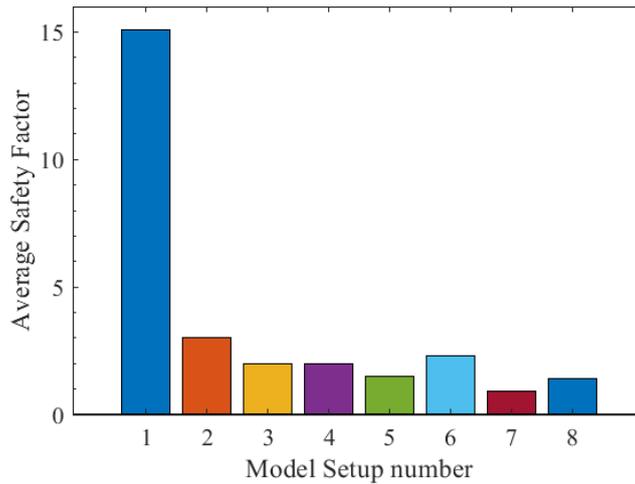
Figure 26. Average safety factors for different model setups.

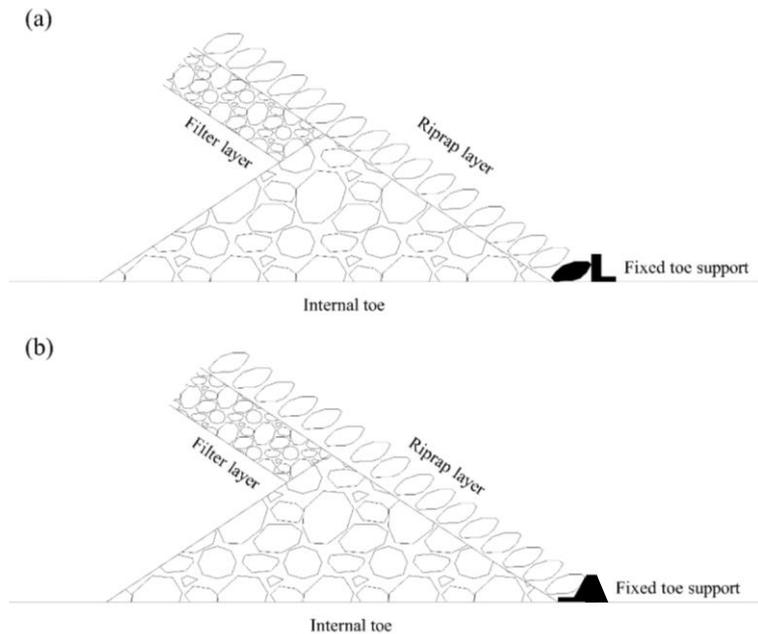
Figure 27. Rockfill dam model with placed riprap models coupled with fixed toe supports.

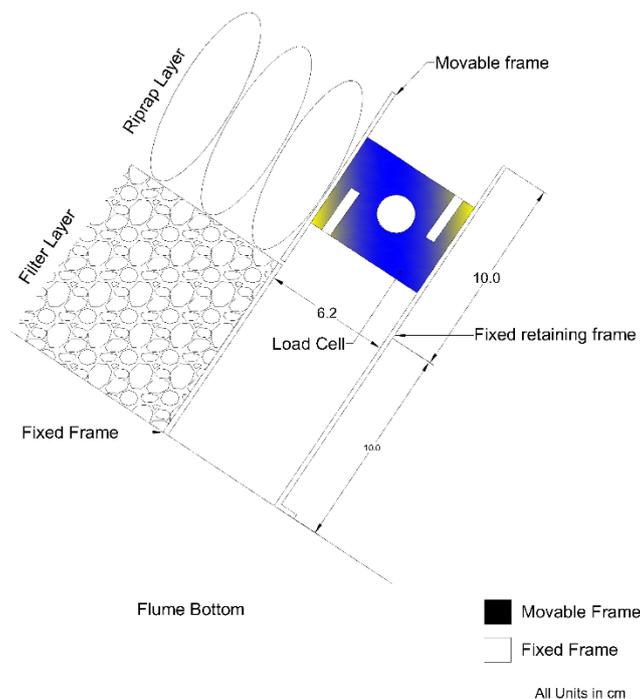
Figure 28. Model setup including load measurement cells at the toe section of placed ripraps.

As part of the experimental research conducted at NTNU, Trondheim, a series of overtopping tests were conducted on placed riprap models provided with load measuring pressure cells at the toe section (Figure 28). The accumulated data is yet to be analyzed as part of future research activities. The study objective would be to arrive at descriptions of the nature and the magnitude of flow forces generated at the toe section of placed ripraps as function of incremental overtopping exposure.

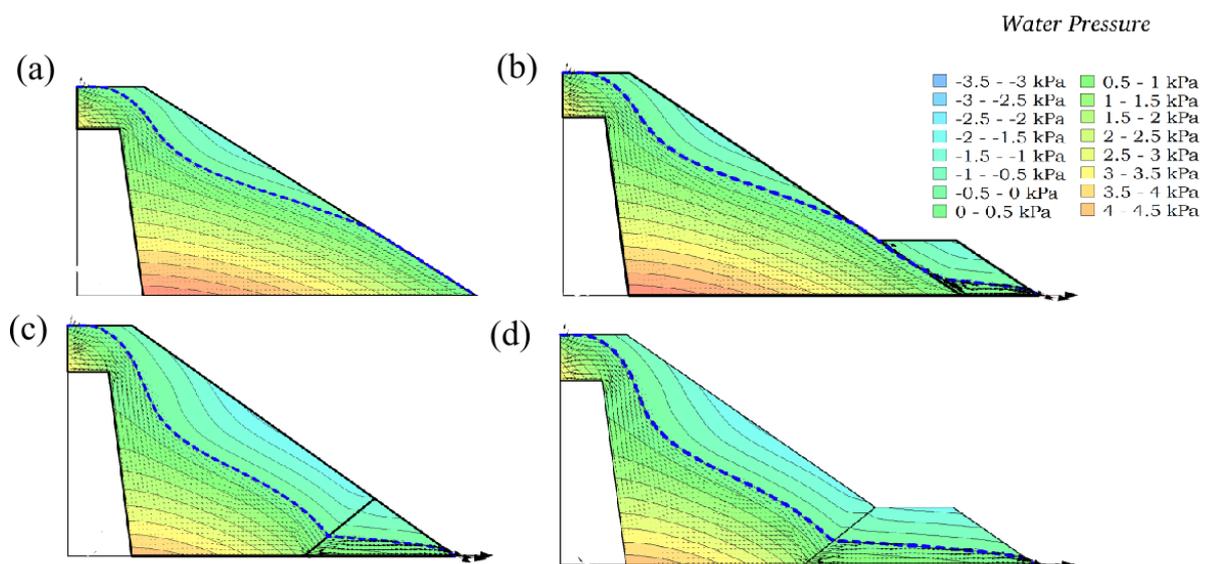
Figure 29. Simulation of flow through the different rockfill dam models. (Fig. Nils S Smith)

Data sets accumulated as part of M3 with regards to modeling of flow through rockfill dams to investigate the effects of different toe configurations on throughflow development are being further used as part of ongoing research. The aim of the investigation is to calibrate a widely used seepage model to predict flow through rockfill dams. Figures 29 and 230 present some of the outcomes from the study. The results appear to be promising with regards to the ability of the calibrated models to simulate throughflow development within the dam structures.

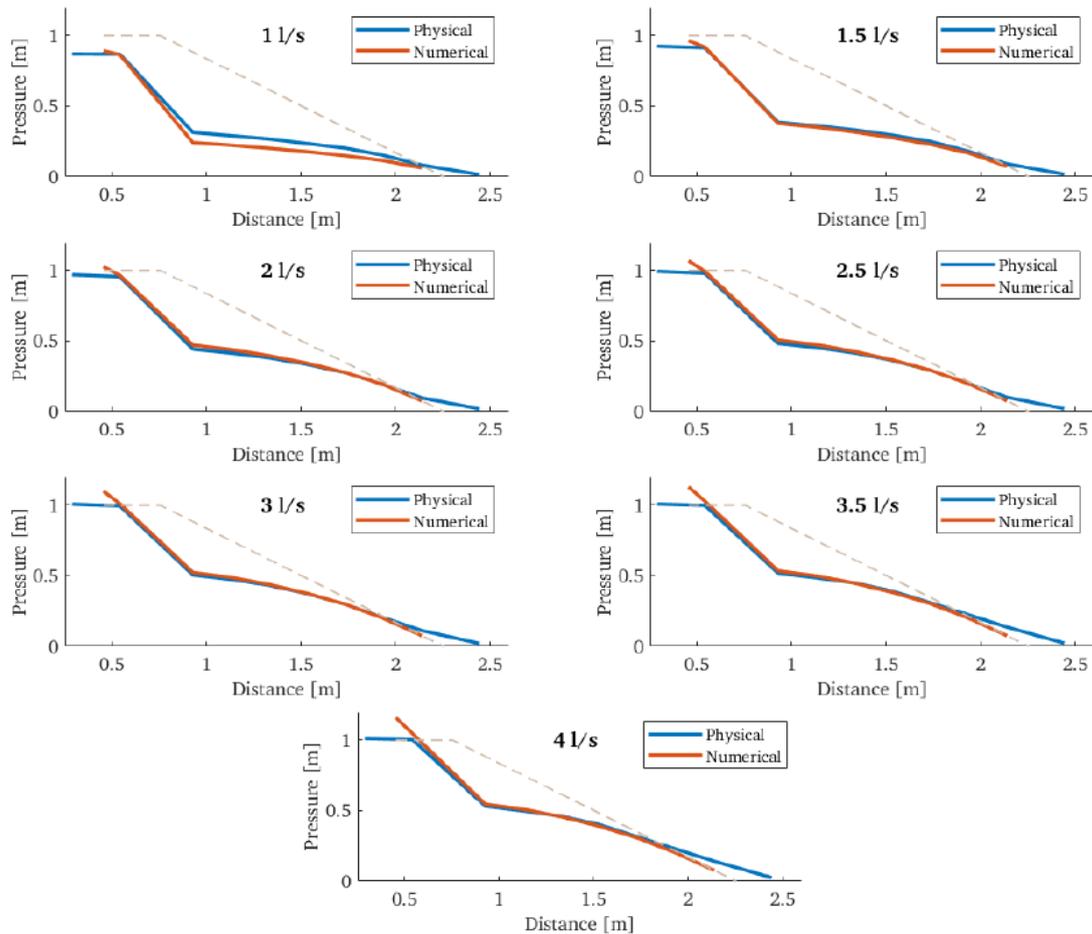
Figure 30. Comparison of physical observations with numerical predictions.

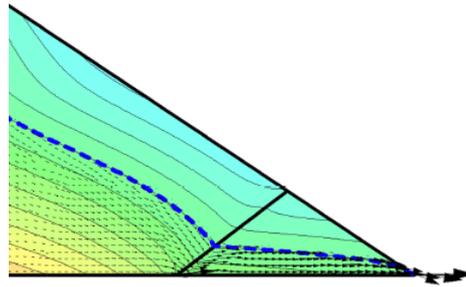
Figure 31. Depiction of the assumed triangular toe configuration.

For instance, construction of a purely triangular toe would be practically very challenging due to the sharp nature of the tip of the toe.
