# The unstable phyllitic rocks in Stampa – Flåm, western Norway: Compilation, scenarios, risk and recommendations

## NVE Report no. 35 – 2013

**Abstract:** The report presents a compilation and summary of all existing data on the unstable slopes in the Stampa-Flåm area, presents a risk classification and gives recommendations for the future risk handling. The unstable area is characterized by relatively small movements without any signals of increased deformations, and a follow-up in terms of a revision of existing displacement measurements is considered to be sufficient in order to handle the risk in the Stampa area. Based on the relatively low risk connected to the largest scenarios and the limited knowledge on the hydrological conditions, it is in the present situation not recommended to initiate any mitigation measures in terms of larger drainage systems. This conclusion follows the recommendations from the international expert panel.

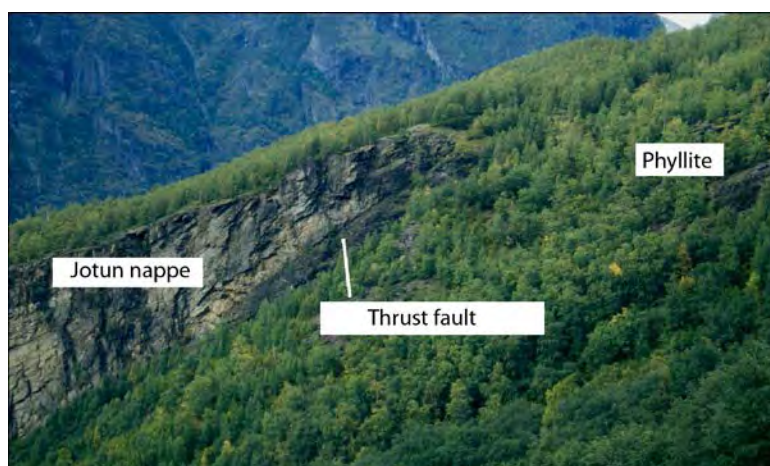
**Figure 4:** The thrust fault of the Jotun Nappe with The underlying phyllitic rocks. View towards north.

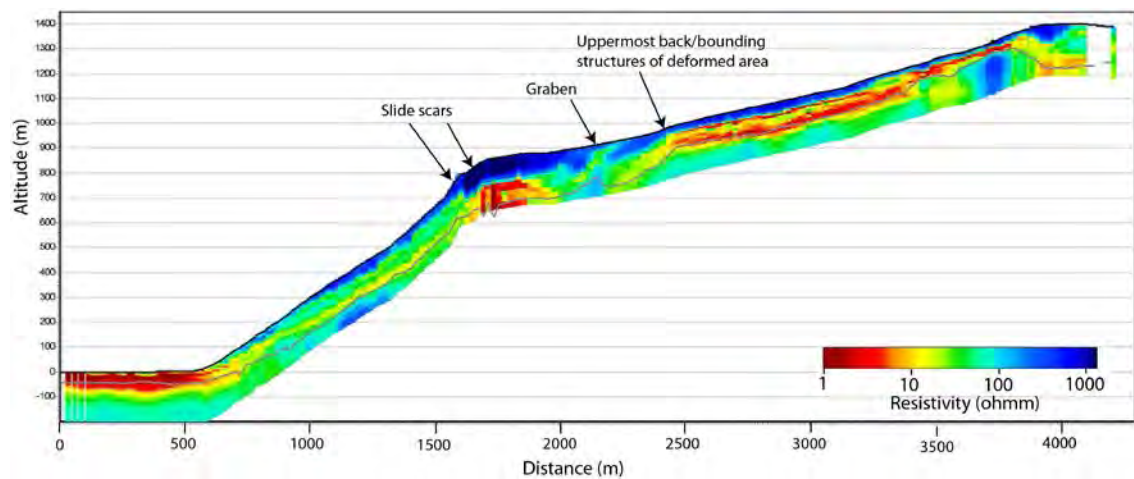
Figure 9: AEM data from profile 240. Location in Figure 7.

- There is a relatively clear transition within the phyllitic rocks between the undeformed low resistivity phyllitic rocks and the deformed and unstable phyllitic rocks with higher resistivity to the west (Figure 7 and Figure 8). The unstable area has undergone major deformations characterized by open fractures, which seem to influence the resistivity conditions. This high resistivity zone is especially evident at the slope break going from the plateau and down the steep slope, where the zone seem to be about 100 m thick (Figure 9). Furthermore, this indicates that the area is well drained.

- Relatively high resistivity characterizes the surface of lower slopes covered by landslide debris. If this indicates the debris coverage, it shows that the landslide debris thickness can be up to 50 m thick, but locally with thin cover or exposed bedrock (Figure 9 and Figure 10).

A stability analysis for the area just north of Stampa was done by Grimstad (2008) in connection with the evaluation of possible drainage measures. However, the limited information about the subsurface conditions, and especially the hydrological conditions, make this analysis difficult to use. The potential sliding planes was set to between 16 and 24°, and the water in fractures was allowed to increase up to the terrain surface. The safety factor was calculated to 1.3 in dry conditions, and goes down to about 1 at maximum water pressure. The conclusion was that the rock mass was stable in dry conditions, but can be unstable with maximum water pressure in fractures. A situation with water in fractures being totally filled up to the surface seems to be unrealistic in these highly fractured rocks, also demonstrated by the resistivity data (e.g. Figure 9).

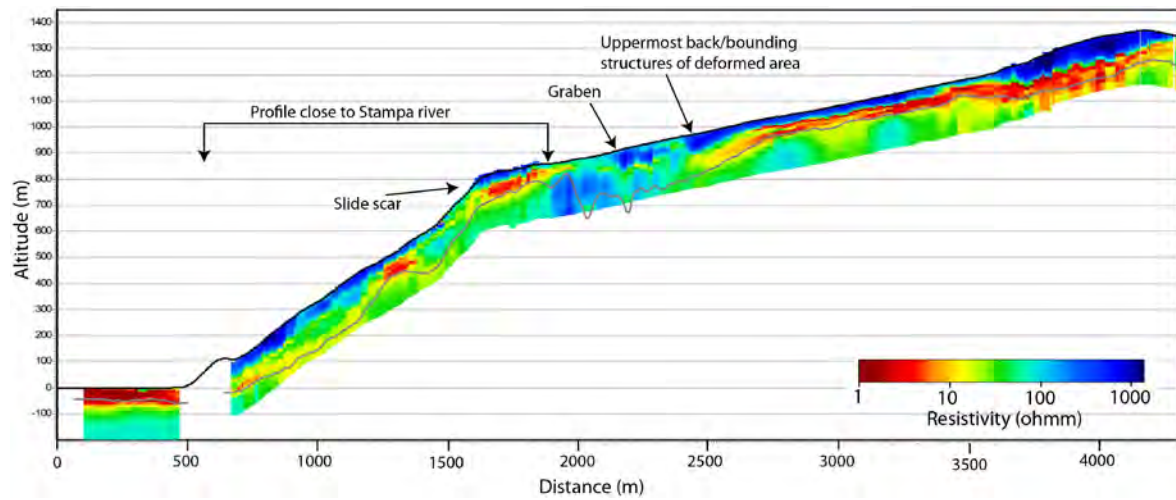
**Figure 10: AEM data from profile 260. Location in Figure 7.**

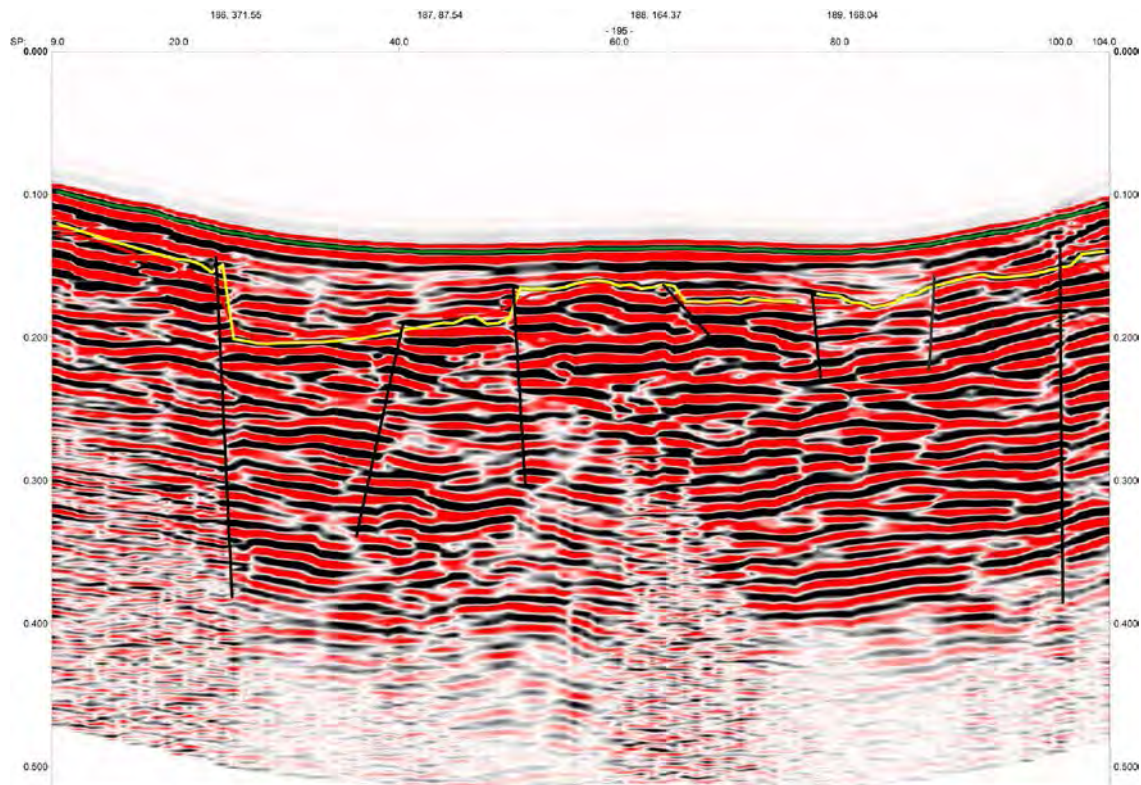
Figure 12: GPR profile 195 (Brenne et al., 2011). The depth penetration is 20-25 m.

A ground penetrating radar (GPR) study was performed in the graben area at Joasete by students at the University College of Sogn og Fjordane (Brenne et al., 2011). The data show that the graben area is characterized by deformations including subsidence of blocks, large fractures and probably crushed areas in the entire penetrating depth down to 20-25 m (Figure 12). Also several percussion drillings were performed by the students, with maximum depth of 17 m. The main conclusion is that the graben area is characterized by displaced blocks, open spaces, crushed material and is well drained.

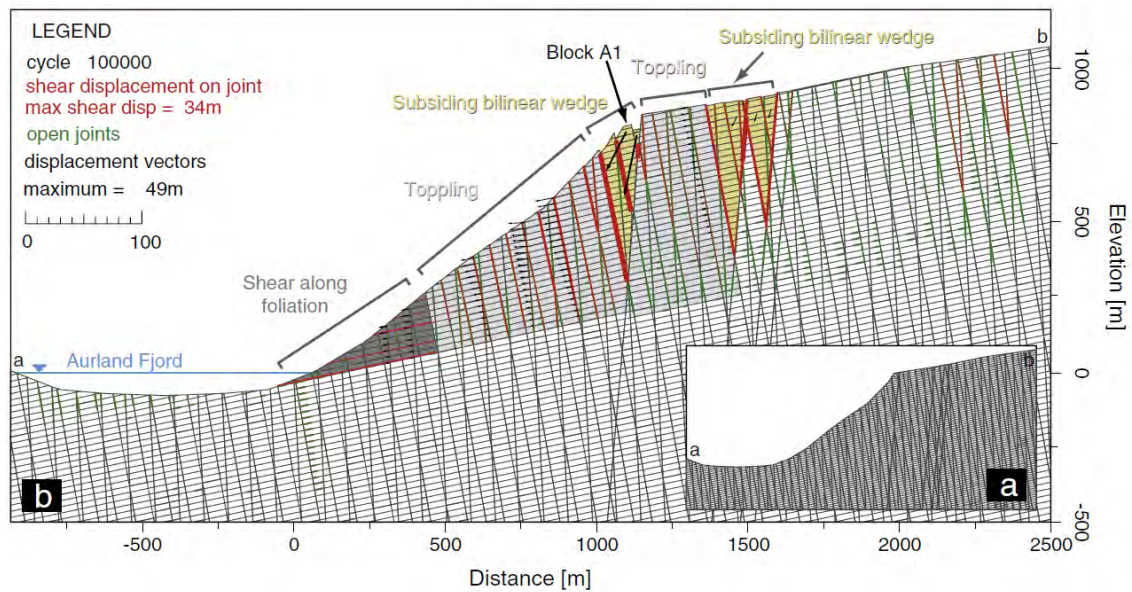
Figure 15: Stability model (Bøhme et al., 2013). Block A1 is sceario 3a in Figure 16.

The 2D UDEC model was used in order to evaluate the failure mechanisms. Testing of different geometrical configurations confirmed that all observable structures need to be included into the model in order to get the highest deformation at the slope crest and to be able to reproduce today's morphology. Also, the implementation of weak structures defining the large graben structure on the plateau was needed in order to form these features. A complex failure mechanism was proposed based on the numerical modelling (Figure 15):

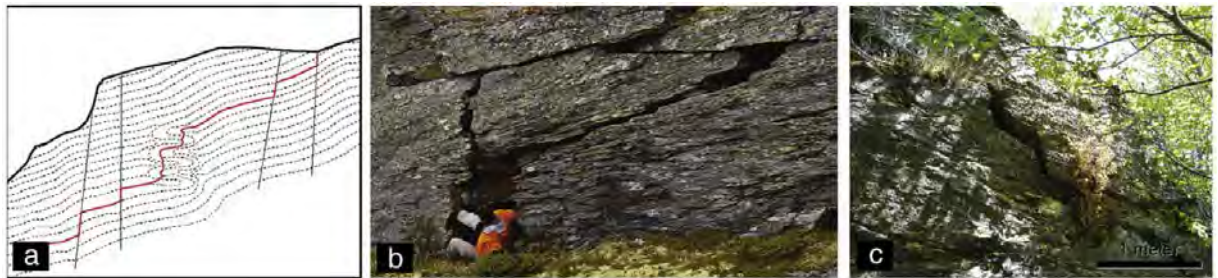
**Figure 17. A complex basal failure surface as proposed by Bøhme et al. (2013). (a) A schematic profile indicating that the failure surface follows foliation in some parts, but steps down along pre-existing joints or fold hinges. (b) and (c) Step-path failures observed in smaller scale in the field.**

Bøhme et al. (2013) have suggested a complex model for the basal failure surface in the area (Figure 17). Evaluation of possible failure surface is based on the assumption that the foliation is gentle ( $12^\circ$ ) throughout the potential unstable areas and that there is a need for large steps and deformation processes to destruct large rock bridges.

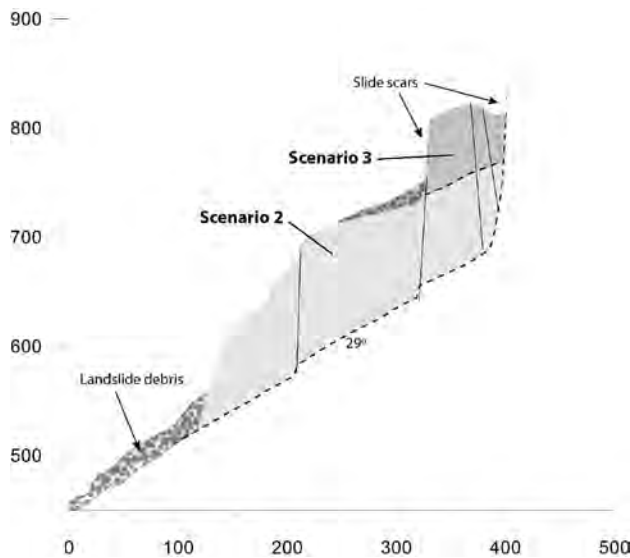
**Figure 21:** Profile 2 north of Stampa, see location in Figure 16 and Figure 19.

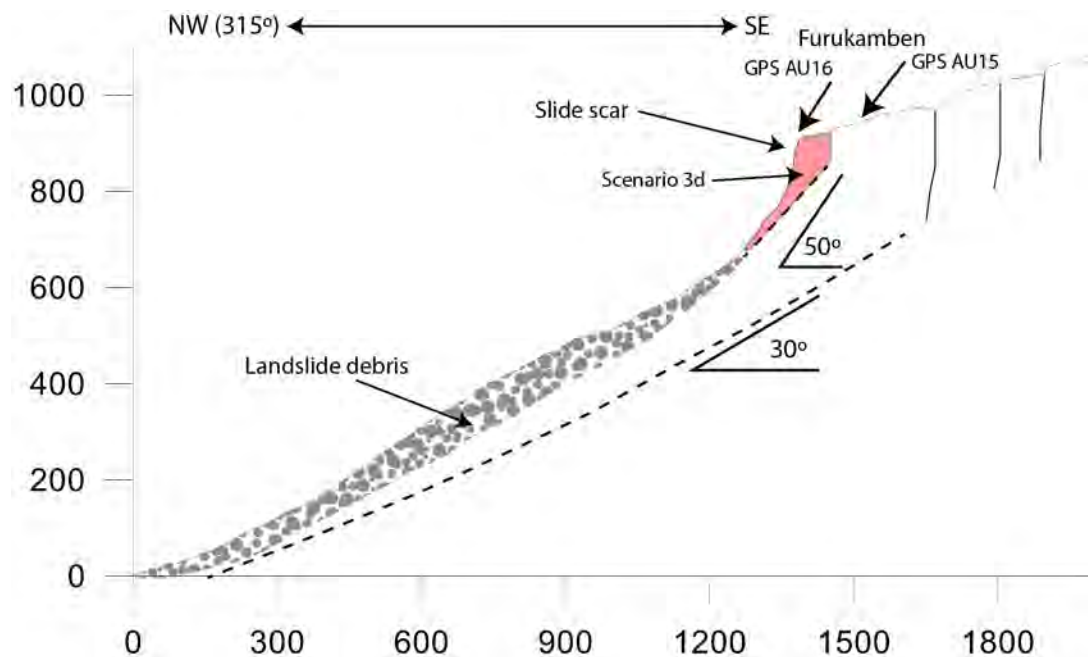
Figure 22: Profile 3 from Furukamben. See location in Figure 16. The plunge of the GPS points is indicated.

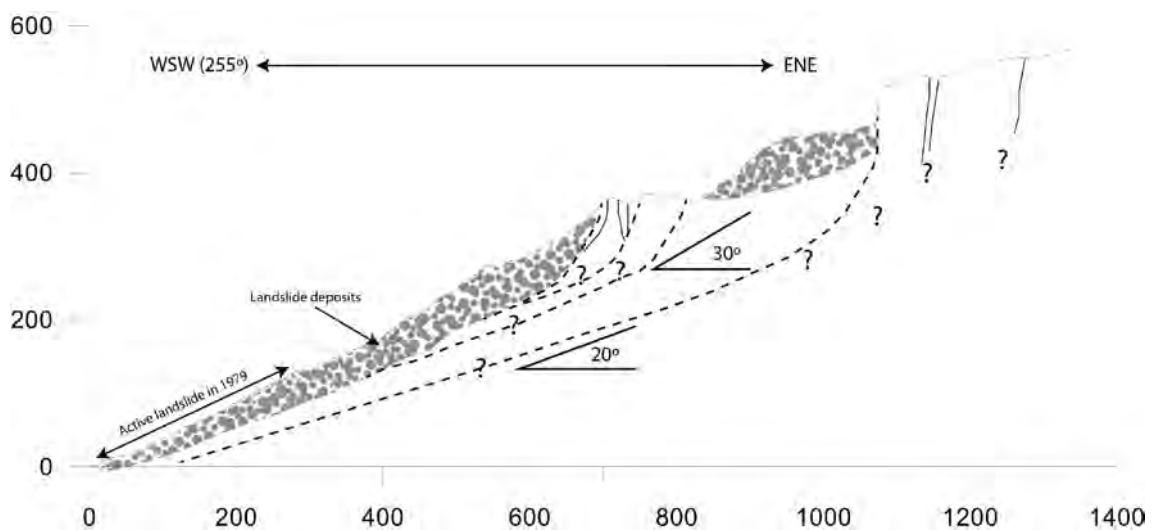
Figure 23: Profile 4 from the northern area southeast of Otternes. See location in Figure 16.

A major back scarp with large slide blocks developing into landslide debris is mapped southeast of Otternes (see profile 4 in Figure 23). The lower part of the blocky landslide debris was active in 1979 and moved about 11 m and passed the main road at the shoreline. Foliation measurements show direction and dip that can be consistent with sliding surface. A GPS point along the back scarp also indicates movements. The topographic conditions and the geological/geometrical model indicate that the detachment zone is relatively gentle and that the most probable landslide behaviour is slow movements with a less probability of evolving into a rapid landslide (Figure 23). This will probably also be the case for the area further to the east at GPS AU14 (scenario 3b), north of Joasete (Figure 16 and Figure 19).

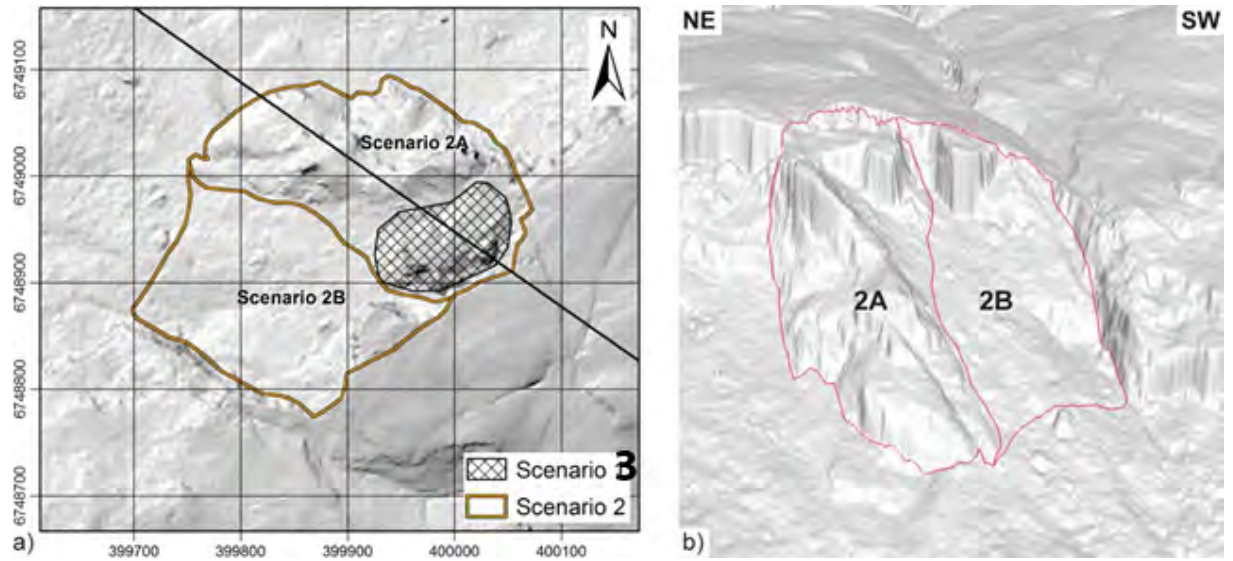
**Figure 27: (a) Hillshade map of scenario 2 with two possible extents (scenario 2a and scenario 2b), which both include the detached frontal block of scenario 3a (coordinates in UTM 32N); (b) 3D view of scenario 2. Note that the scenario in the text is named 2a and 2b (not 2A and 2B).**

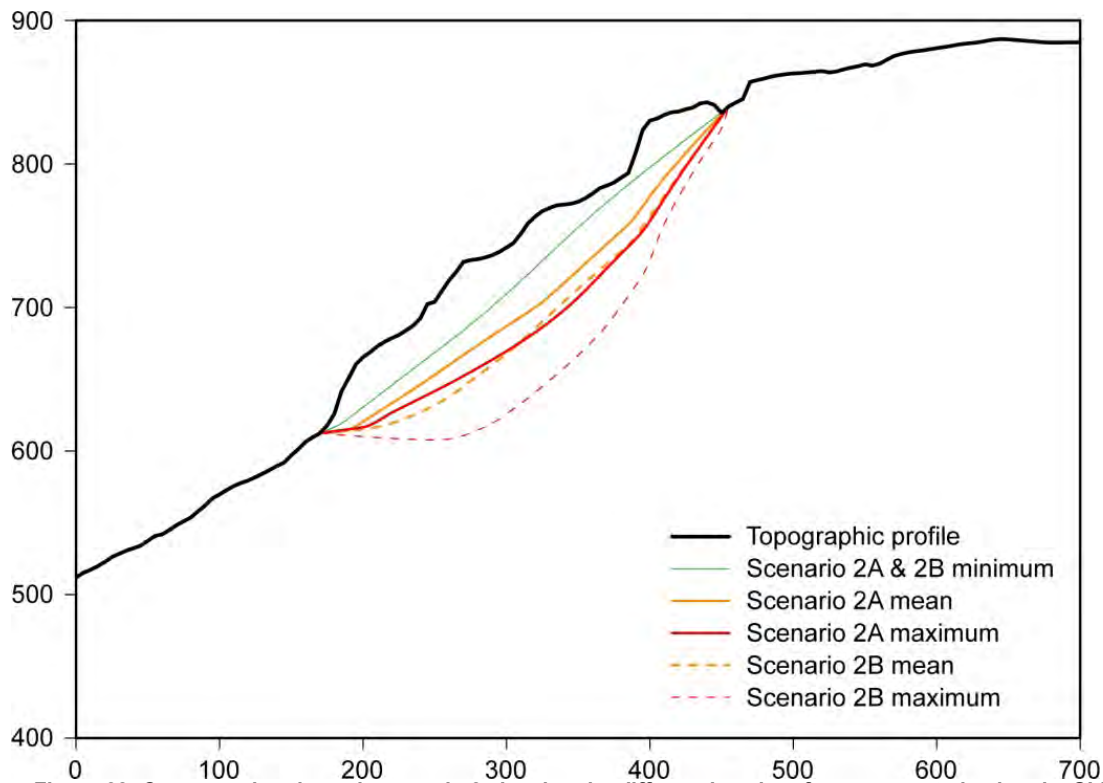
**Figure 28: Cross-section through scenario 2 showing the different basal surfaces computed using the SLBL technique with different curvature parameters. The most likely basal surfaces are shown as thick lines. Note that the numbering is 2a and 2b in the text.**

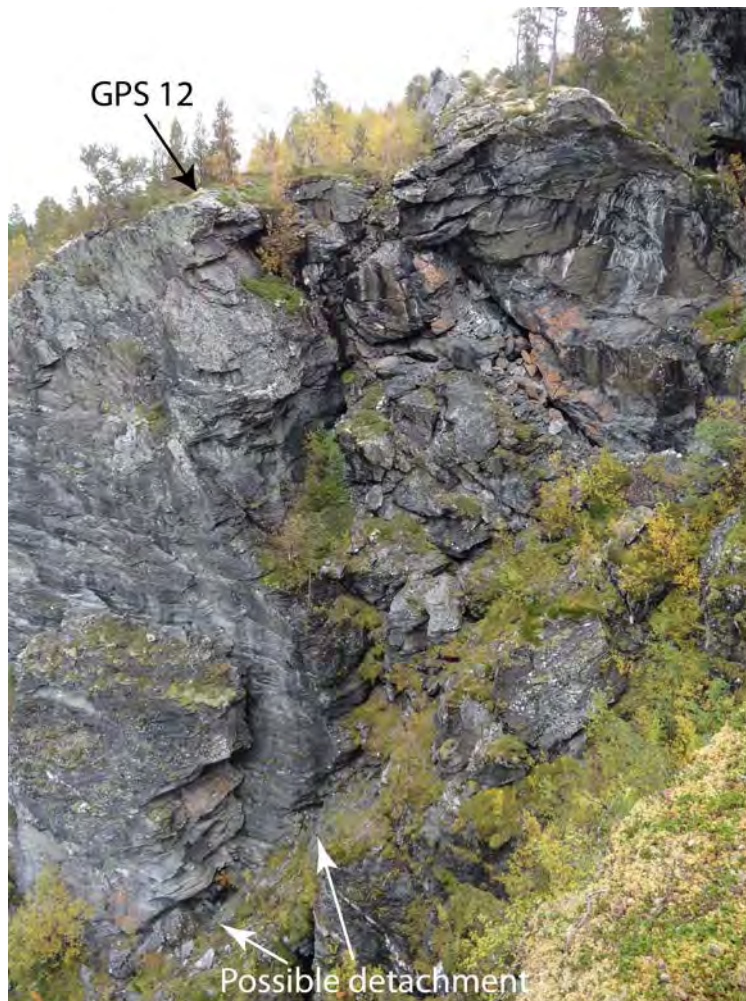
**Figure 29:** View towards scenario 3a. Note the possible detachment surface. Location of GPS 12 with an annual displacement of 9,5 mm/year is shown together with the possible detachment surface. Photo: Reginald Hermanns (NGU).
