Glacier lake mapping with Sentinel-2 imagery in Norway

Teodor Nagy and Liss M. Andreassen

Rapport, engelsk nr 40-2019

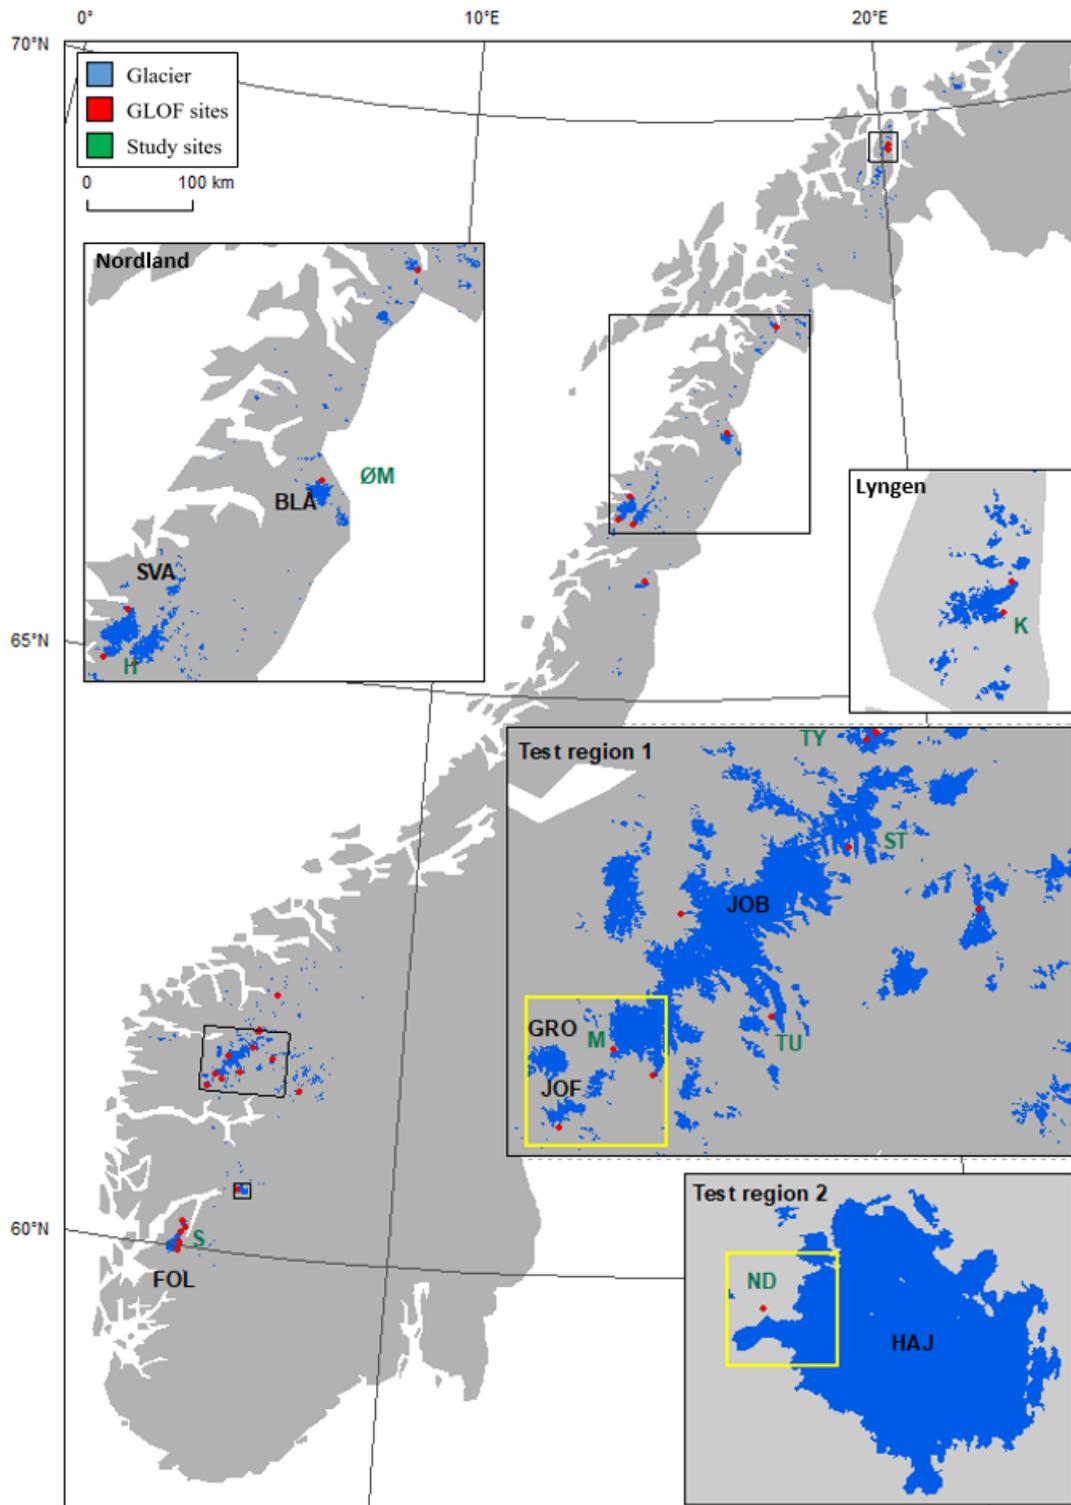
Figure 1: A map of Norway showing subsets in test regions 1-2 (yellow boxes), lake sites (green font), and main glaciers (black font) referred to in the report. Regions Nordland and Lyngen are also shown as close-ups. All GLOF sites recorded in NVEs Breatlas up to and including 2018 are shown in red. Abbreviations: FOL: Folgefonna; HAJ: Hardangerjøkulen; JOF: Jostefonni; GRO: Grovabreen; JOB: Jostedalsbreen; SVA: Svartisen; BLÅ: Blåmannsisen; S: Sauvatnet; ND: Nedre Demmevatnet; M: Marabreen lake; TU: Tunsbergdalsbreen lake; ST: Styggevatnet; TY: Tystigbreen lakes; H: Heiavatnet; ØM: Øvre Messingmalvatn; K: Koppangsbreen lake.

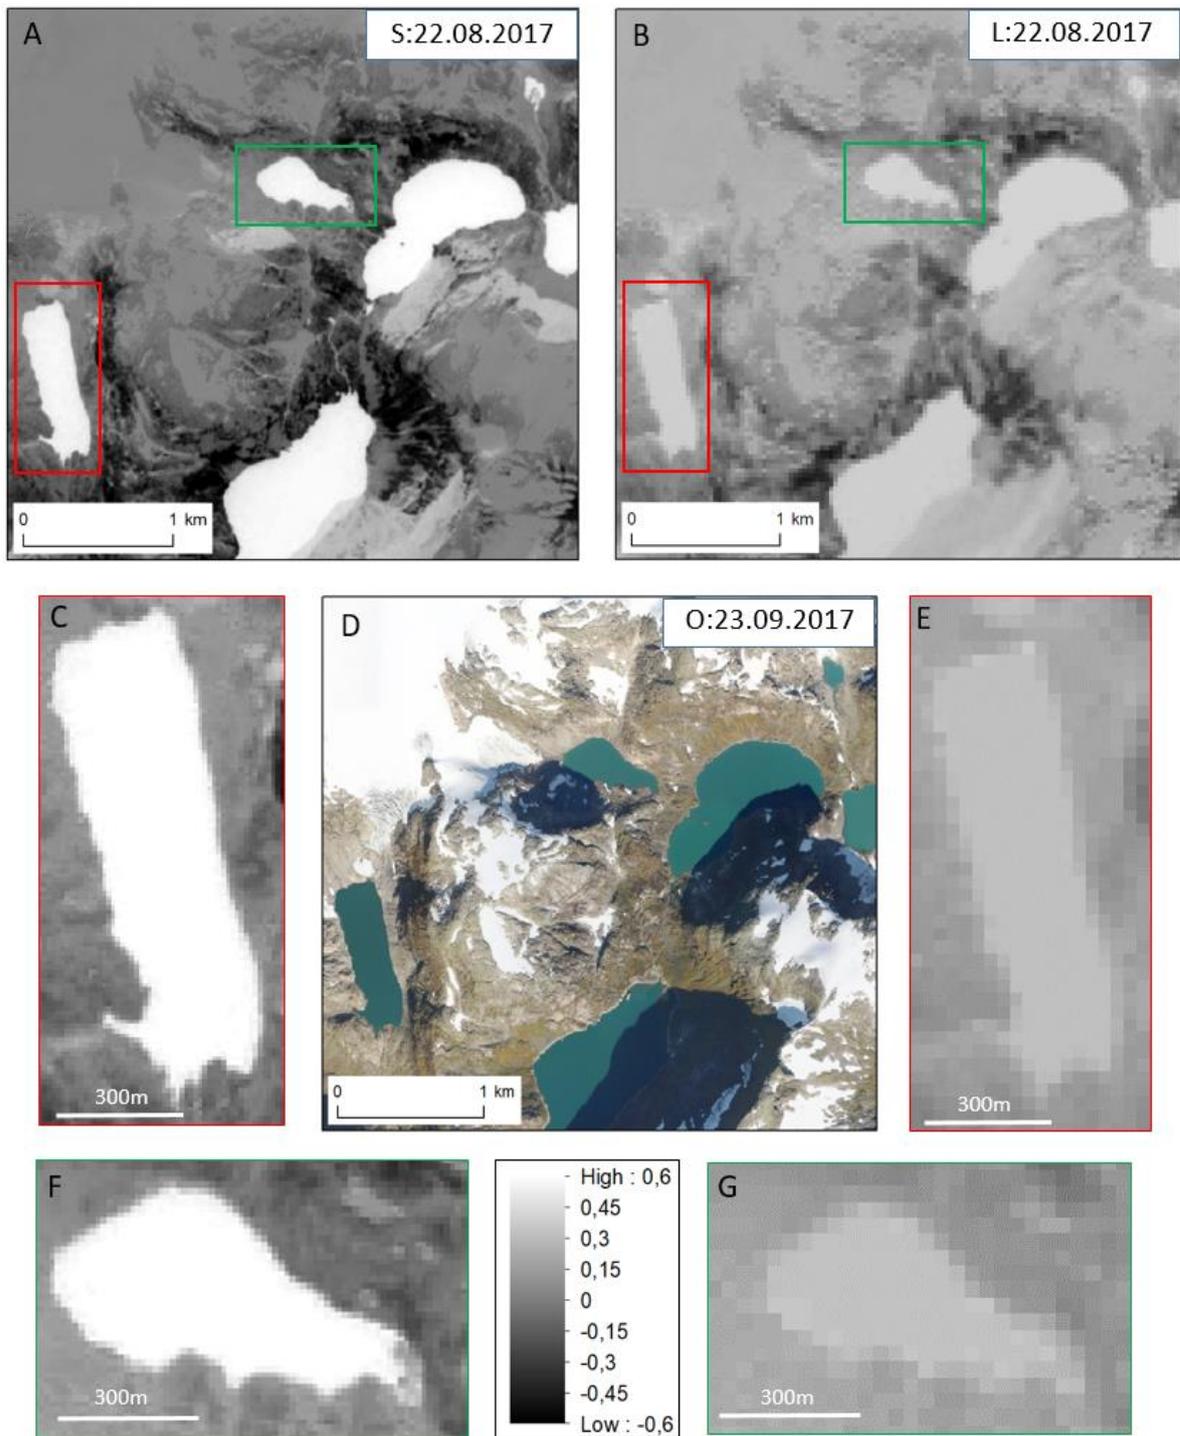
Figure 2: NDWI maps of Sentinel-2 (S) and Landsat 8 (L) scenes, as well as orthophoto (O) of lakes at southern Jostefonni glacier (part of test region 1, see Figure 1) showing varying level of observable lake outline detail. Close-up of the NDWI maps of the lakes of southern Jostefonni from 22/08/2017 using Sentinel-2 (C and F) and Landsat 8 (E and G) imagery.

The Sentinel-2A satellite was launched into orbit on 23/06/2015 (Paul et al., 2016). After the launch of the Sentinel-2B satellite on 07/03/2017, the amount of data has doubled (Cagriotta and Knowelden, 2017). The combination of the Sentinel 2A-2B constellation yields an observation every five days at the equator and more frequently at higher latitudes, which makes the Sentinel 2A-2B constellation superior to other missions including Landsat 8 with longer revisit times (Li and Roy, 2017). Sentinel-2A and Sentinel-2B satellites also currently provide the highest ground resolution freely-available imagery at a 10m ground resolution. The Sentinel-2A and Sentinel-2B missions carry a multi spectral instrument (MSI), which provides 13 reflective wavelength bands; four 10m visible and near-infrared (NIR) bands, six 20m near-infrared and short-wave infrared (SWIR) bands, and three 60m bands (Zhang et al., 2018). In comparison, the most recent Landsat mission, the Landsat 8, carries an operational land imager (OLI) and thermal infrared sensor (TIRS) and has nine reflective wavelength bands designed for land use, with the highest panchromatic band ground pixel resolution being 15m, compared to the Sentinel 2A-2B constellation's 10m (Loveland and Irons, 2016). Sentinel-2 provides improved details of glacier outlines and crevasses (Paul et al., 2016, Nagy et al., 2019). The green and NIR bands (3 and 8) of Sentinel-2, often used to compute the NDWI, are provided at a 10m ground resolution (Zhang et al., 2018), whereas the corresponding bands 3 and 5 of Landsat 8 are provided at a 30m ground resolution. Effectively, this results in a nine times sharper imagery of Sentinel-2 compared to Landsat 8 enabling to capture more detailed information of the lake outlines (Figure 2).

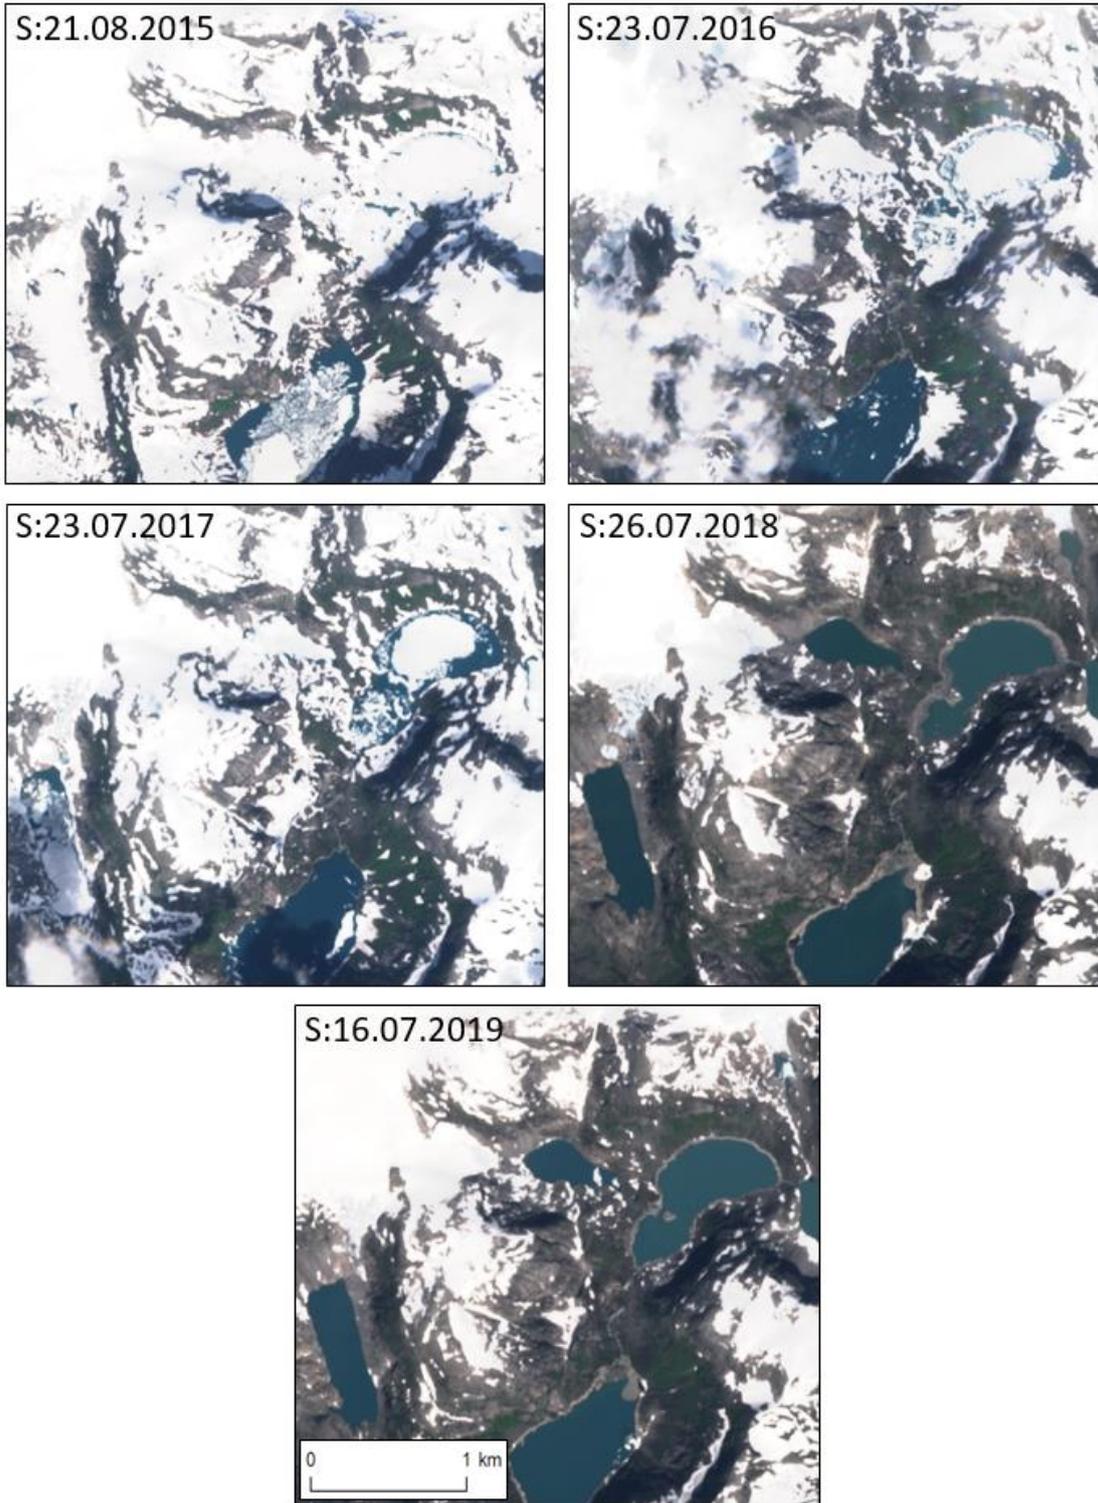
Figure 3: Sentinel-2 natural colour imagery of lake surface conditions in August 2015 and July 2016-2019 of southern part of Jostefonni glacier, test region 1. See Figure 1 for location.

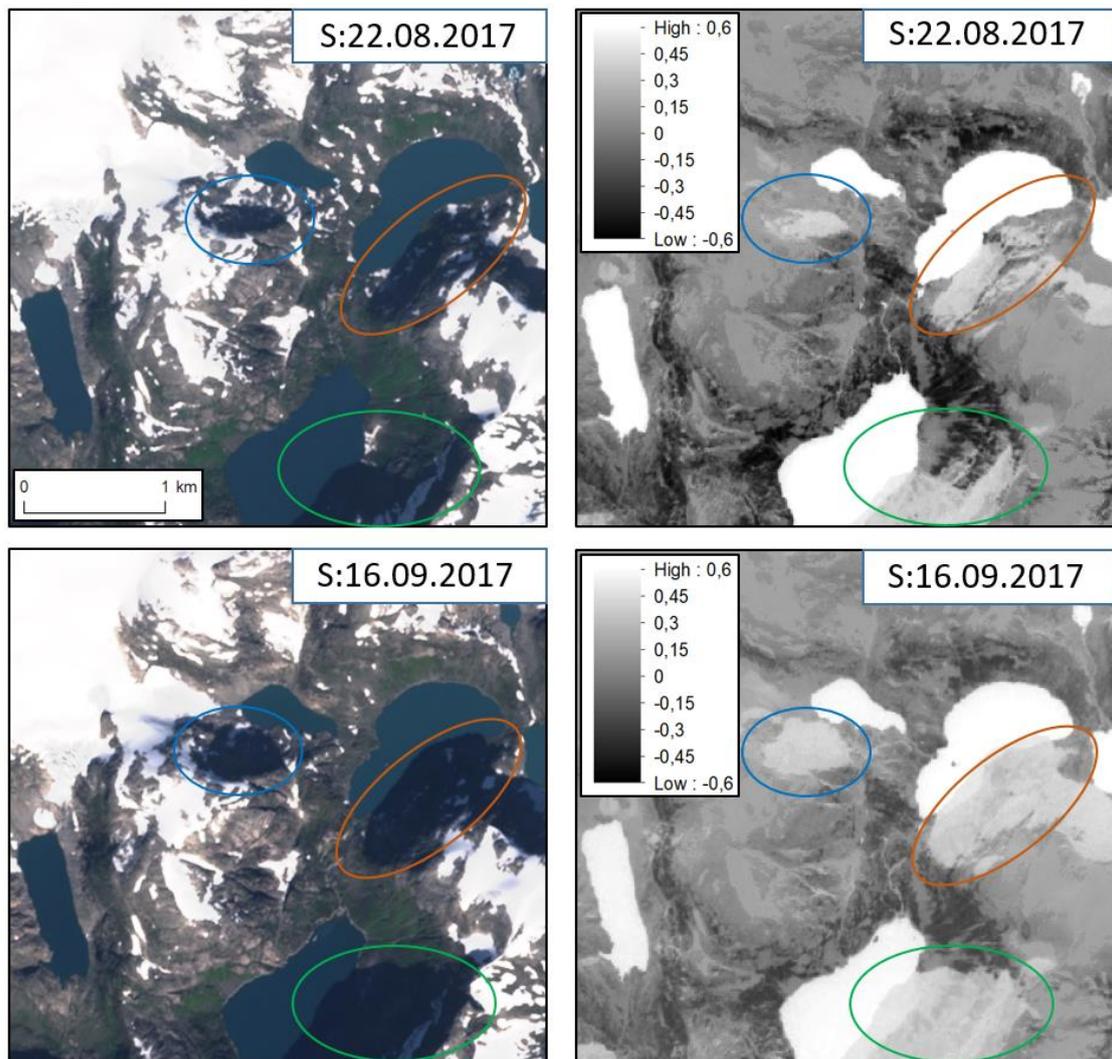
Figure 4: Sentinel-2 natural colour imagery and corresponding NDWI maps illustrating increased spatial extent of terrain induced shadowing in 25 days over southern part of Jostefonni glacier. Three lake-bordering areas influenced by shadowing are depicted in blue, orange and green. High-end positive NDWI values indicate presence of water. Shadowing over stable terrain manifests in increased NDWI values over non-water covered areas. NDWI is explained in detail in chapter 3.4.

The terrain induced shadowing is at its minimum during the summer solstice (~21/06) due to a high sun angle. The further the temporal distance from the summer solstice, the lower the sun angle, and the more widespread the shadowing becomes (Figure 4). This is often problematic for glacier lakes lying north of a mountain ridge or in areas of prominent topography. To minimize the effect of shadowing, imagery that was selected for the analysis was therefore often the first clear image with a full exposure of the glacier lake outlines. Figure 4 shows how shadowing develops in 25 days.

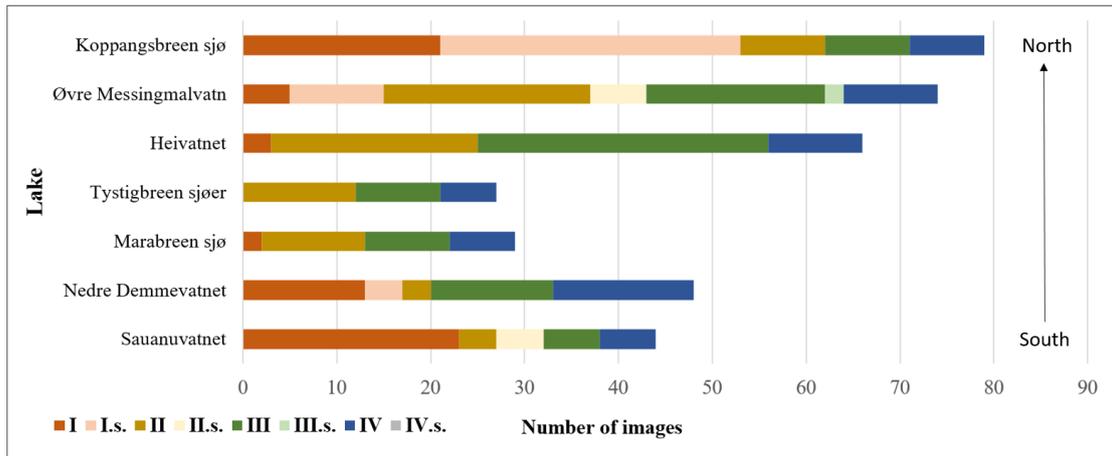
Figure 5: Categorization of Sentinel-2 imagery for the months May-November from 2015-2018 based on its usefulness for glacier lake outline mapping for a subset of seven lakes along the S-N transect. See Figure 1 for location.

Imagery that had 100% cloud cover over the lakes was not included or classified. In total, 375 images were classified for the seven lake sites (Figure 5). The mean of the sample was ca. 54 images per lake site. More imagery was available for the three lake sites in northern Norway. This is mainly due to denser Sentinel-2 observations. Northern Norway is often imaged from three different orbits. Southern Norway is most often imaged from two orbits, but can also be imaged from three orbits. Of 375 images (Table A1), 207 were classified in the I, I.s., II, and II.s. categories. This presents a mean of ca. 30 images per lake for the period 2015-2018, where a perimeter of the lake and its area can be distinguished. More imagery was available from 2017 and 2018 (282 images) than 2015 and 2016 (93 images). This is due to: a) doubled coverage of years 2017 and 2018 by Sentinel-2B satellite; b) Sentinel-2A sensor malfunction and irregular observations in 2015; c) difficult snow cover conditions in years 2015 and 2016. Figure 6 shows the cloud, snow and lake ice conditions over Nedre Demmevatnet in a 4 month period 29/05/2018-28-09/2018. Lake snow, ice cover and cloud cover are limiting the number of useful images for glacial lake monitoring.

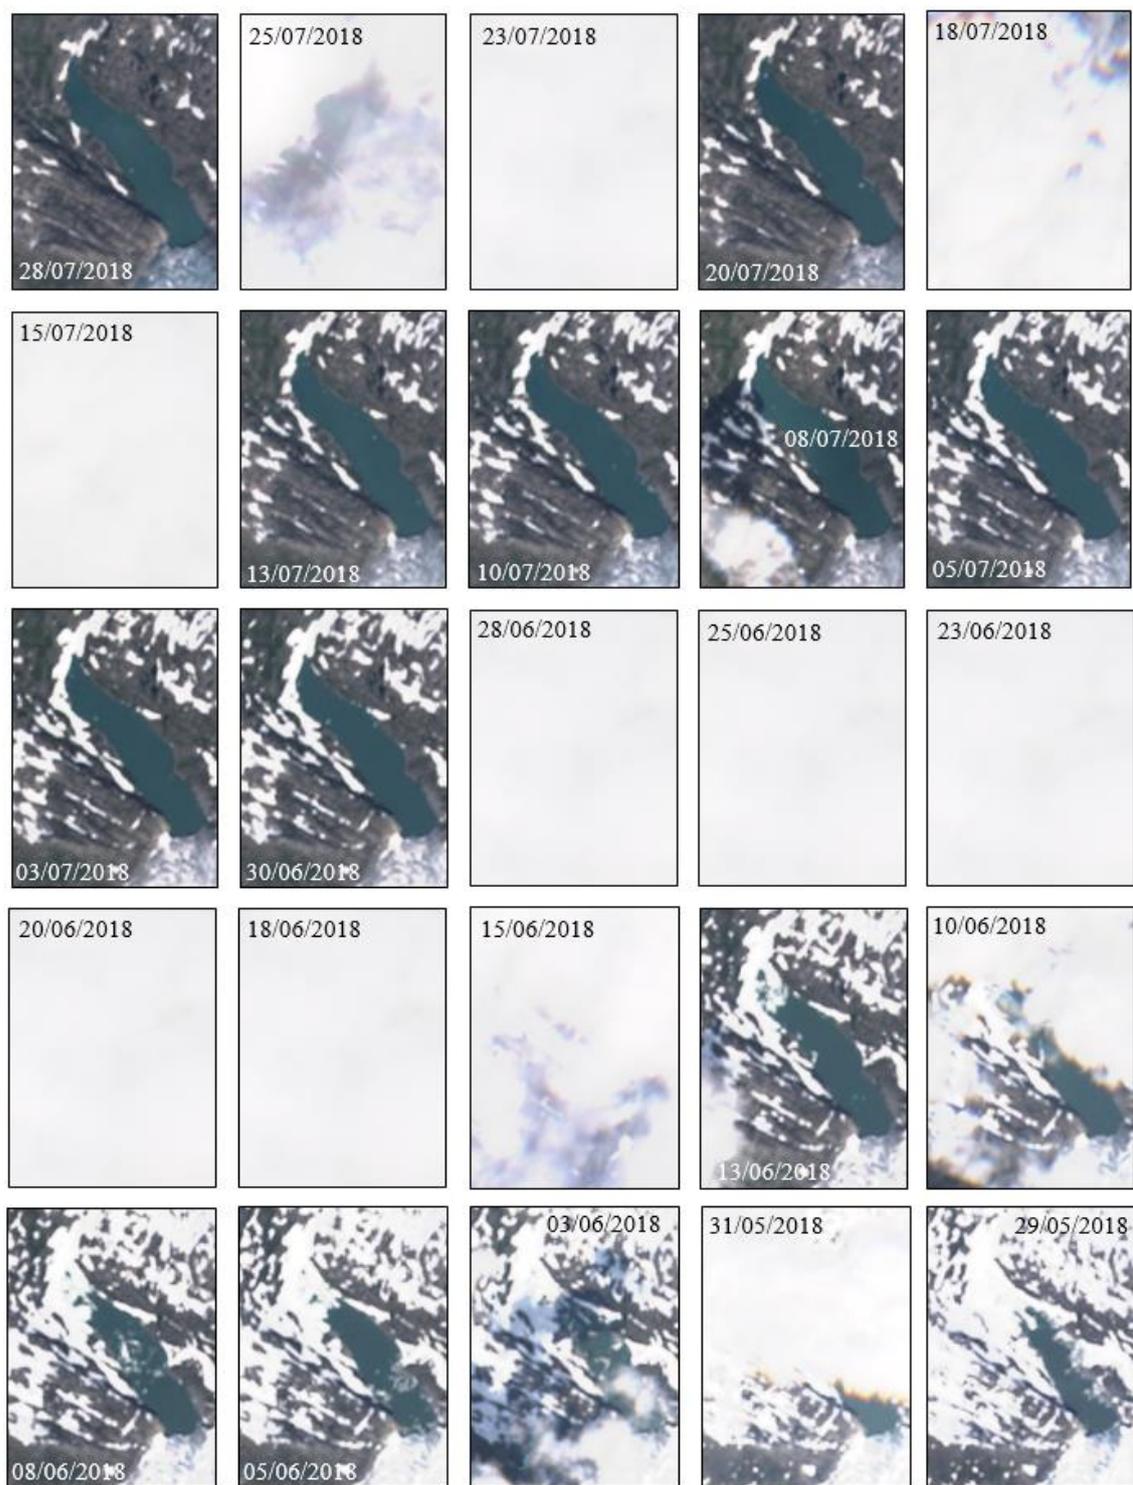
Figure 6: Natural colour Sentinel-2 imagery of Nedre Demmevatnet, glacier dammed lake with a history of jökulhlaup events, from the period 29/05/2018-28/09/2018. For the location, see Figure 1 (test region 2). Dimensions of each of the frames are ca. 0.7 x 1.2km.

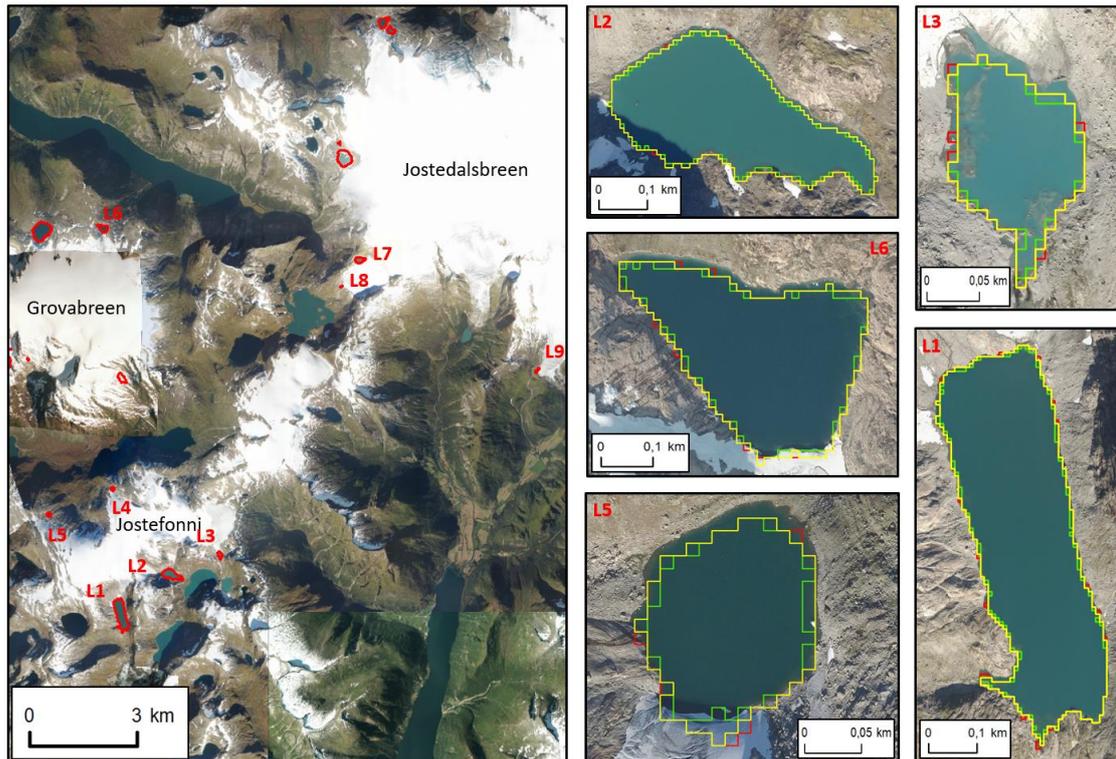
Figure 7: Map of the test region 1 (see Figure 1) showing derived lake outlines in western Jostedalbreen, Jostefonni and Grovabreen including the location of the subset of lakes L1-L9 used for the product accuracy assessment. The lake outlines of lakes L1, L2, L3, L5 and L6 calculated using the Sentinel-2 NDWI image from 16/09/2017 are shown in detail for the thresholds: T0.23 in red; T0.25 in yellow; T0.35 in green. The background orthophotos are from 16/09/2017 and 23/09/2017 and were used to manually digitize the lake outlines.

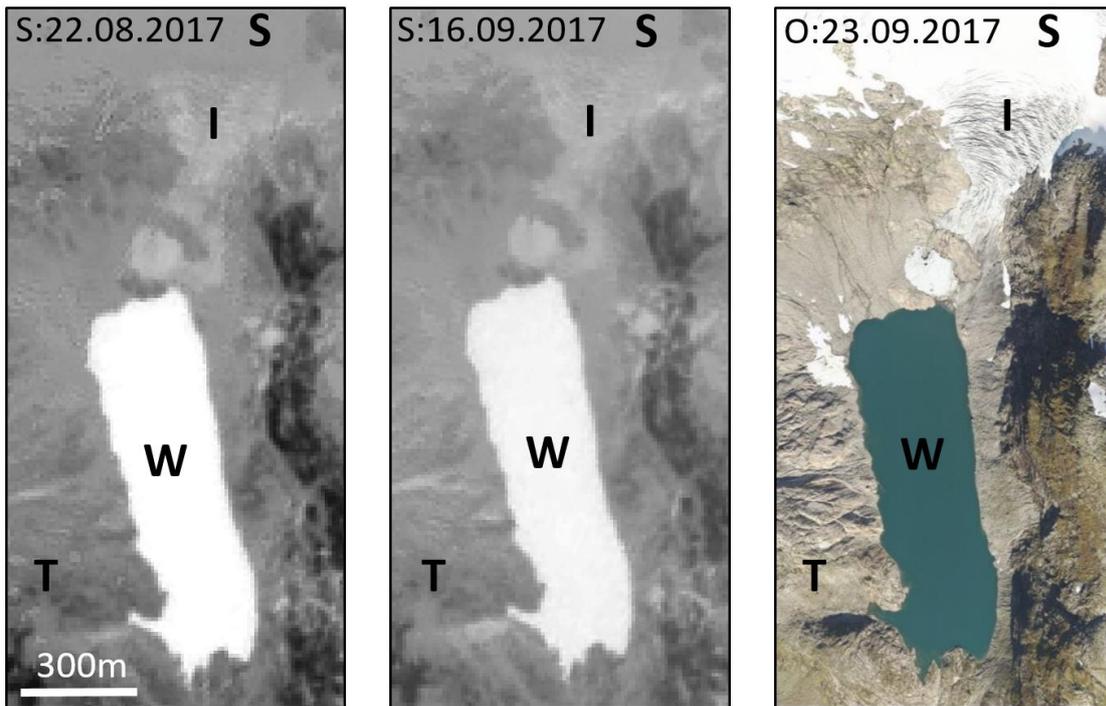
Figure 8: Comparison of the Sentinel-2 NDWI maps with a high-resolution orthoimage, depicting different representation of water (W), snow (S), ice (I) and terrain (T) for lake L1 south of the Jostefonni glacier (see Figure 7 for location).

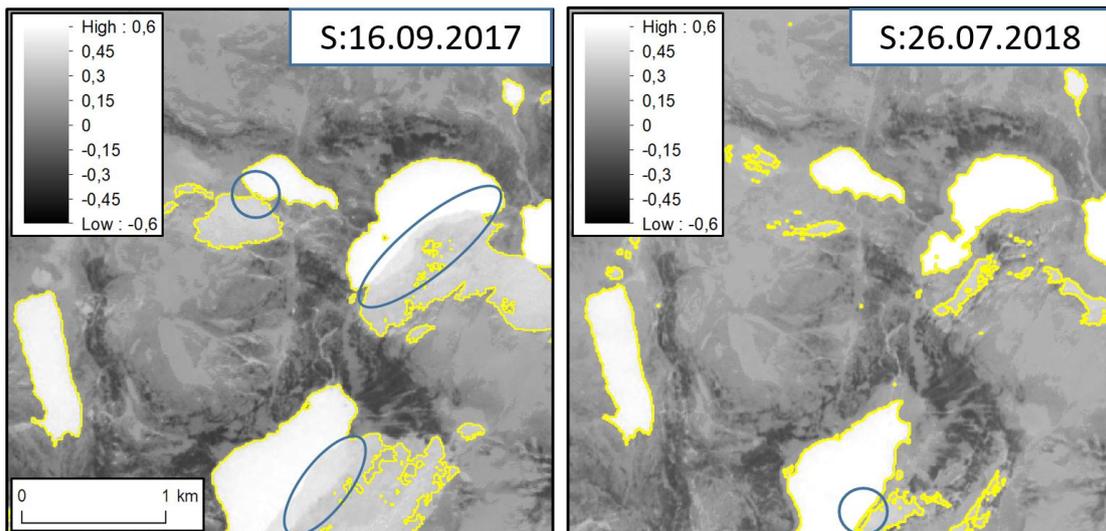
Figure 9: NDWI maps of Sentinel-2 imagery from 16/09/2017 and 26/07/2018 with polygons derived using T0.23 (in yellow) illustrating different inclusion of areas in shadow over a 50 day temporal baseline. The areas that need manual corrections of outlines are highlighted in blue.

To obtain a glacier lake product within a minimal time period only Sentinel-2 imagery from 2018 was used. An image from 26/07/2018 was used for the lake outline mapping in the Jostefonni and western Jostedalsbreen regions and none of the lakes L1 – L9 had terrain induced shadowing. Using a relatively early acquisition results in a reduced need for manual redigitization of the lake boundaries (Figure 9). However, in some of the other regions, glacier lake outlines had to be computed using imagery from September 2018, when terrain induced shadowing is spatially more prominent than in July. Areas of terrain with shadowing have a higher NDWI (Figure 4) than the selected threshold of 0.23, ranging ca. 0.25-0.45. This can result in inclusion of the non-water terrain pixels into water polygons (Figure 9).

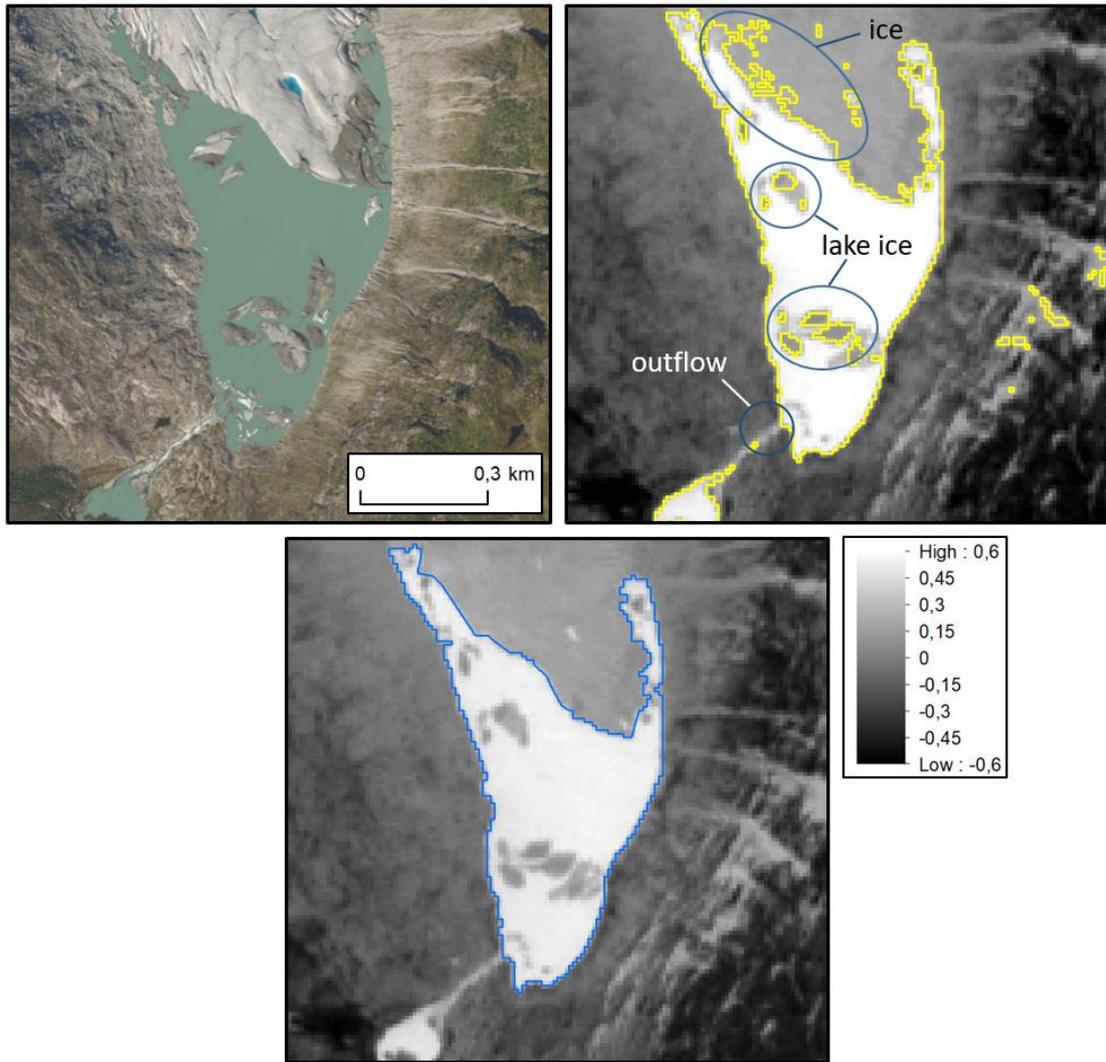
Figure 10: Orthophoto of Tunsbergdalsbreen glacier lake from 26/08/2017 and corresponding NDWI map from 26/07/2018 (with T0.23 outlines in yellow) used for the glacier lake outline mapping in the inventory. The areas where manual correction due to lake ice and glacier ice was needed are highlighted in blue. In the case of Tunsbergdalsbreen proglacial lake, no correction for the lake outflow was necessary as the river outlet was not connected to the lake polygon. Corrected lake outline is shown in blue. See Figure 1 for location.

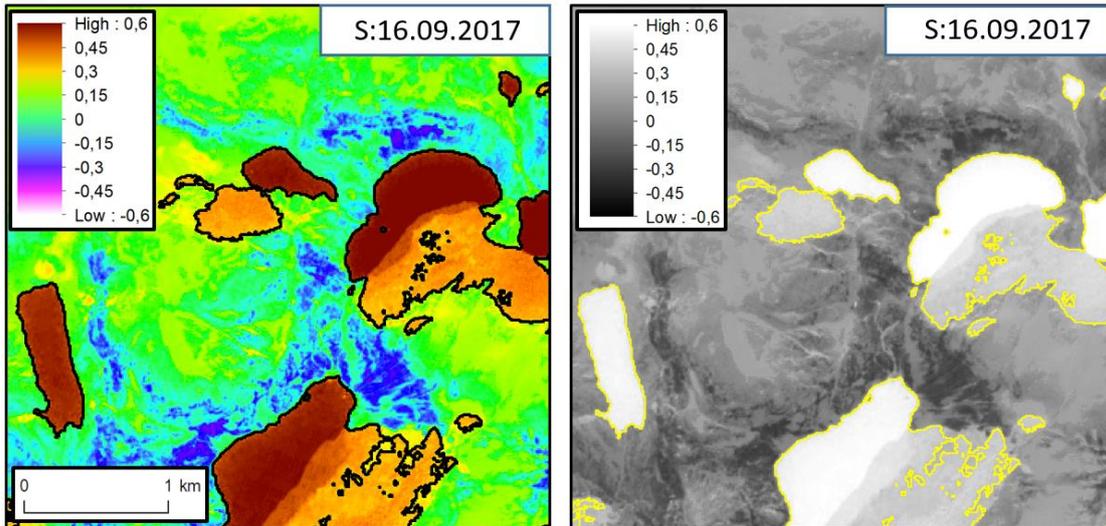
Figure 11: Colourcoded and non-colourcoded NDWI map of southern Jostefonni lake subset from 16/09/2017 illustrating relatively uniform NDWI values (dark brown) of the lake subset with a range of ca. 0.55-0.63. See Figure 7 for location.

The NDWI values varied for lakes in the same region, and within the same image. This can be caused by the different depth of the water, lake sedimentation, and cloud and atmosphere conditions. Maximum NDWI values of 0.40-0.70 are common for most of the lakes throughout the inventory. Figure 11 illustrates similar NDWI values in a range of 0.55-0.63 for the same subset of the lakes from southern Jostefonni.

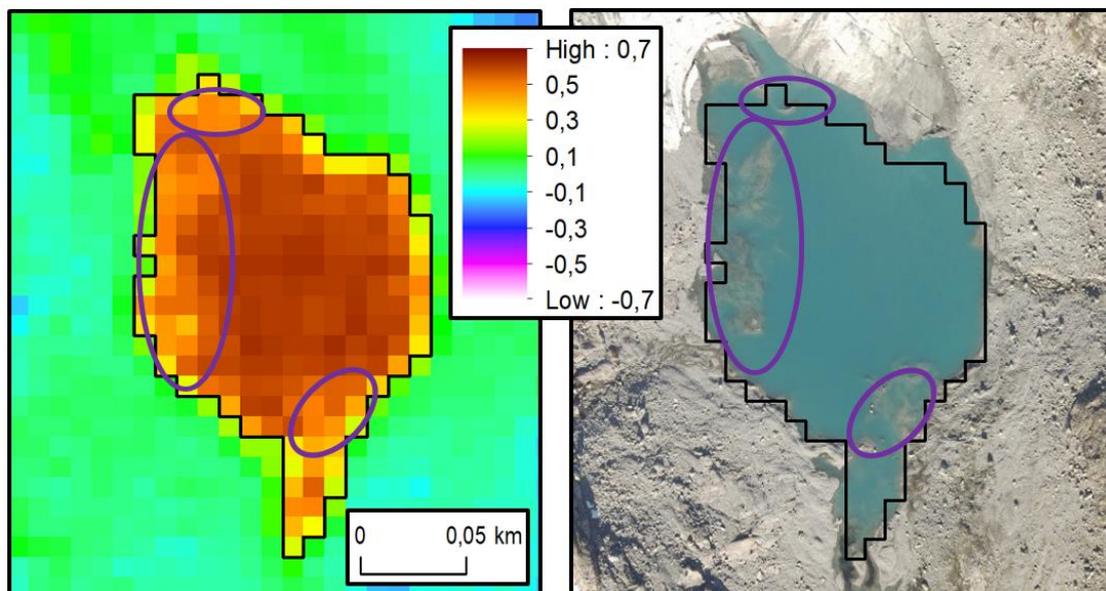
Figure 12: NDWI map from Sentinel-2 image from 16/09/2017 and orthophoto from 23/09/2017 of Lake 3 (L3) revealing contrasting NDWI values in the area of shallow water highlighted in purple ellipses, with visible underlying bedrock or underlying sediment forms. Lake outline in black was calculated using T0.23. The relative positional accuracy of the orthophoto to the Sentinel-2 acquisition was ca. 5-10m. See Figure 7 for location.

The calculated NDWI maps revealed that values can vary within a single lake. This can be due to different water depth in the lake. The NDWI values of Lake 3 (L3) vary from ca. 0.43-0.50 in shallow areas to ca. 0.60-0.63 where there is no visible bedrock or sediment under the water surface (Figure 12).

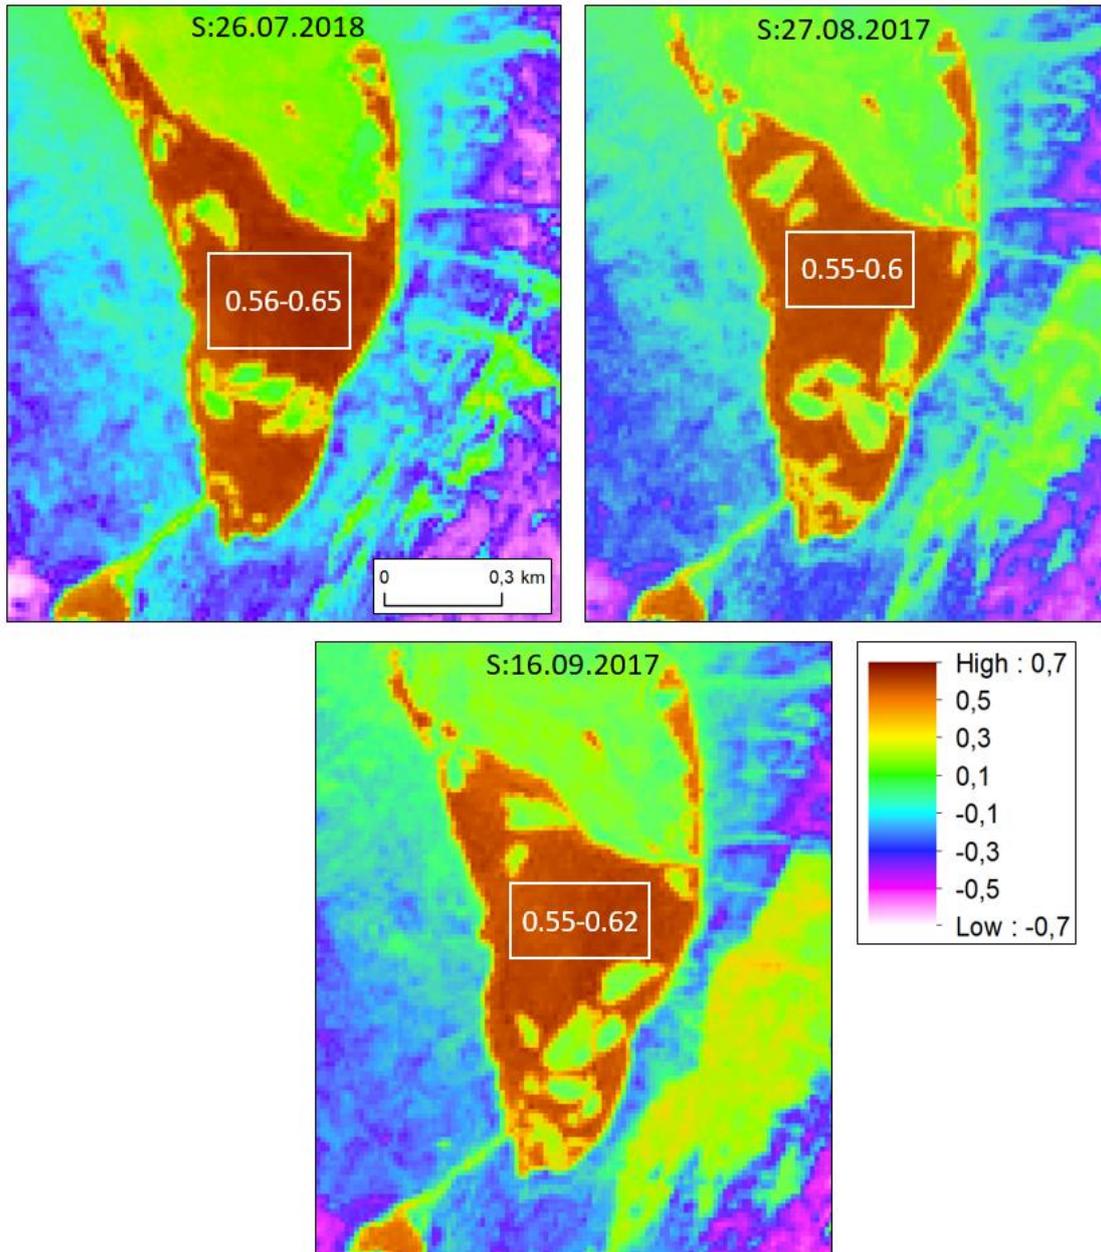
Figure 13: Three colourcoded NDWI maps of Tunsbergdalsbreen glacier lake illustrating temporal variation of the NDWI. The maximum NDWI over the water surface is shown to fluctuate by up to 0.05 points, when the index maps from 26/07/2018 and 27/08/2017 are compared. See Figure 1 for location.

In addition to spatial variations in lake NDWI, temporal variations were also found. For the Tunsbergdalsbreen proglacial lake, the NDWI fluctuated from 0.55 to 0.65 using images from 27/08/2017, 16/09/2017 and 26/07/2018 (Figure 13). The temporal variation can, similarly to the spatial variation, be caused by changed water turbidity, sediment load, water depth, and atmosphere conditions. Since most of the water bodies have NDWI values in a range 0.40-0.70, our threshold value of 0.23 used in the mapping of lakes is low enough to include the majority of the water bodies.

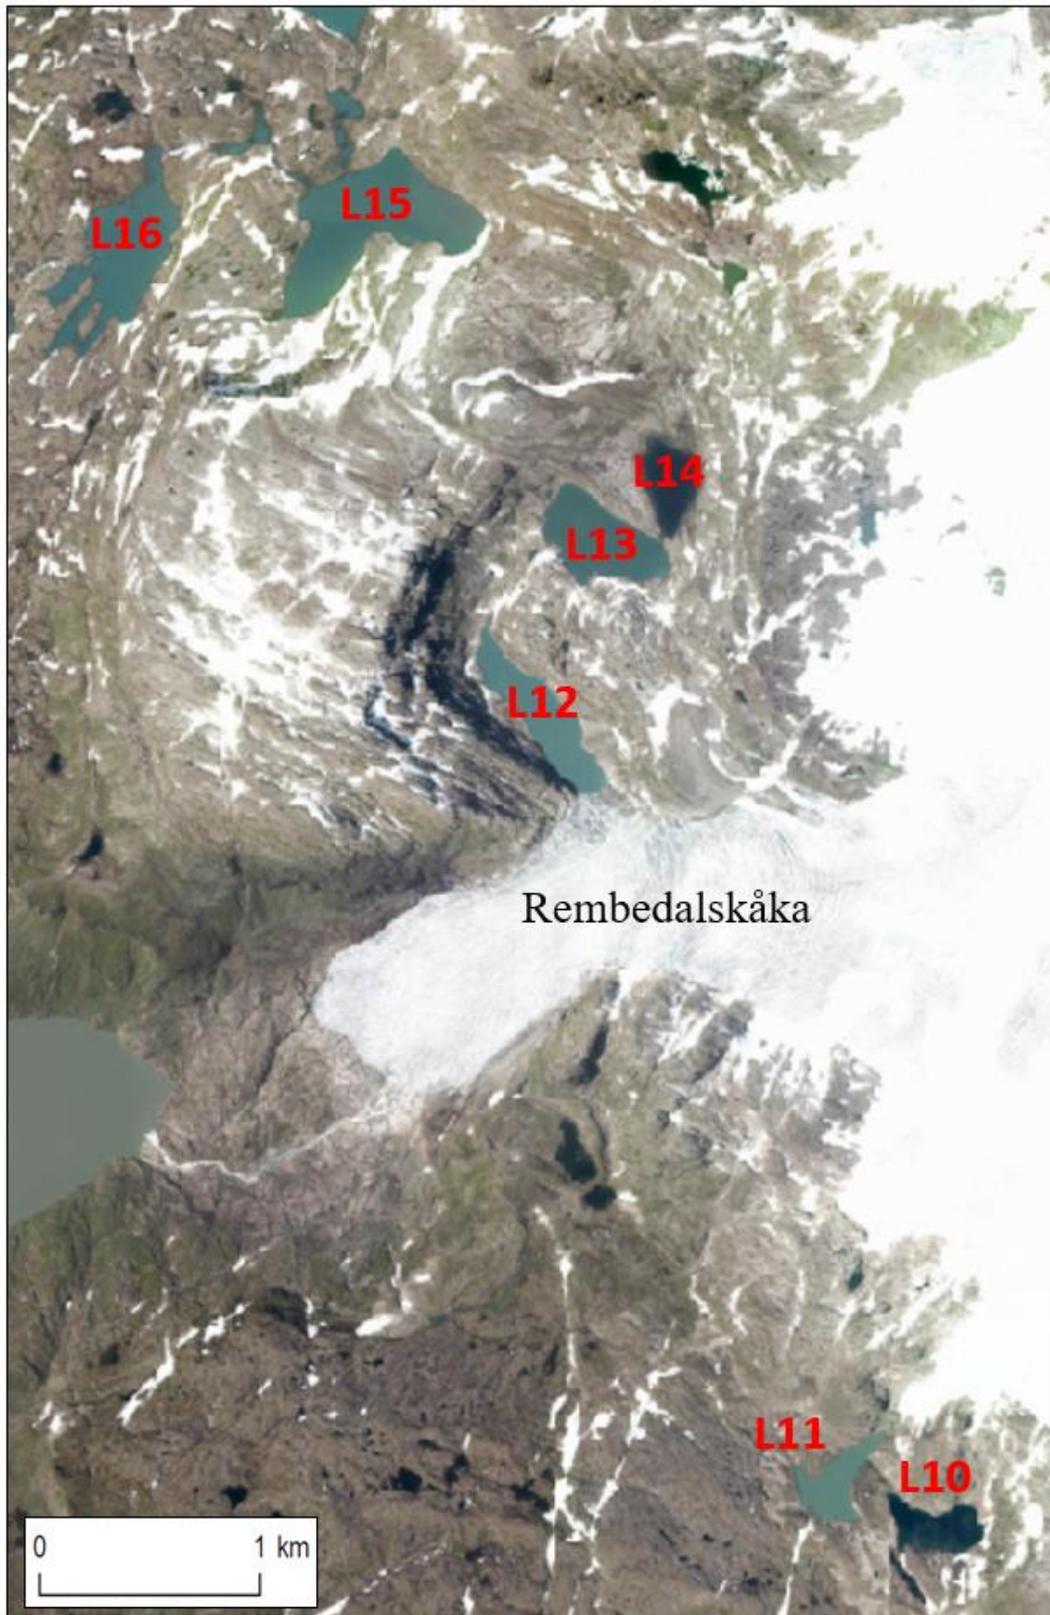
Figure 14: Orthophoto from 20/07/2013 depicting the location of lakes L10-L16 in test region 2 and the western part of the Hardangerjøkulen ice cap with Rembedalskåka glacier tongue. See Figure 1 for location.

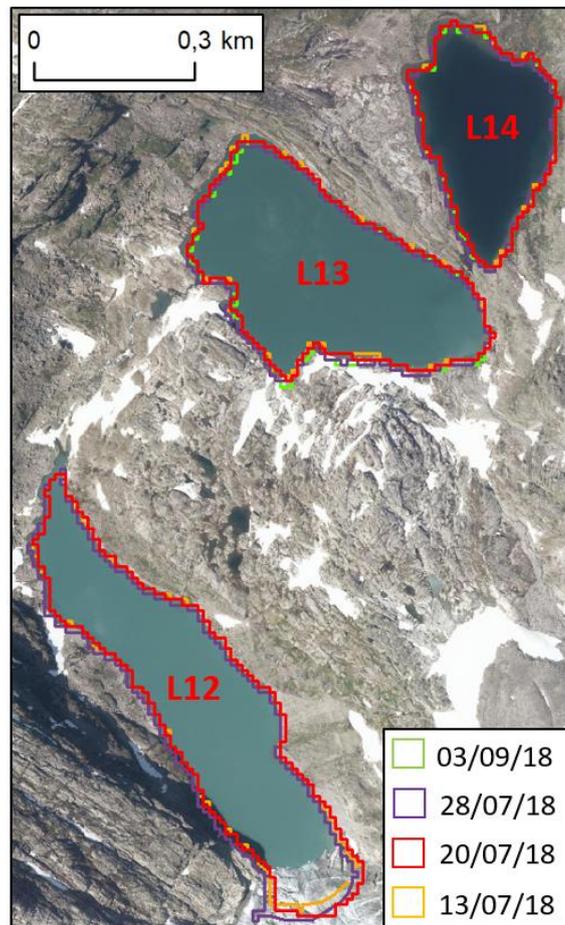
Figure 15: Variation of the glacier lake outlines L12-L14 in test region 2 acquired with threshold T0.23 over a time series of NDWI maps from 2018. Background high resolution orthoimage is from 20/07/2013. Ice-lake boundary was manually corrected for NDWI maps from 13/07/2018 and 28/07/2018. See Figure 14 for location.

To further assess suitability of threshold T0.23 for the inventory, a time series of the NDWI maps from 2018 was used. NDWI was calculated over the region west of Hardangerjøkulen ice cap, containing a lake subset (test region 2) of seven lakes (L10-L16) (Figure 14). The imagery selected for the analysis had minimal cloud, snow and lake ice cover (Figure 6). Four images in the period 13/07/2018-03/09/2018 were used. Lake area of all seven lakes was observable except for two cases. The first one being cloud coverage over part of lake L16 in 28/07/2018 acquisition and the second one being the lake L12 (Nedre Demmevatnet) that was empty in acquisition on 03/09/2018. Manual correction was needed to adjust for terrain induced shadowing affecting NDWI values in the acquisition from 03/09/2018 over lake L15 and at the ice-water interface of Nedre Demmevatnet (L12) in acquisitions from 13/07/2018 and 28/07/2018 (Figure 15). Percentual variation between the smallest and largest observed areas for each lake using a consistent threshold value ranged from 1.5 to 6.2% with an average percentual difference of 3.1% (Table 3). No trend in dates with largest observed area was detected. All but one of the lakes from 13/07/2018 were spatially smaller than the calculated areas from other three images. This is likely due to residual snow or ice cover over lakes, which marginally increased the omission of the water pixels. The images from 28/07/2018 and 03/09/2018 used for the evaluation were not available as corrected images with DTERRENGDATA resulting in positional differences of calculated lake outlines (Figure 15).

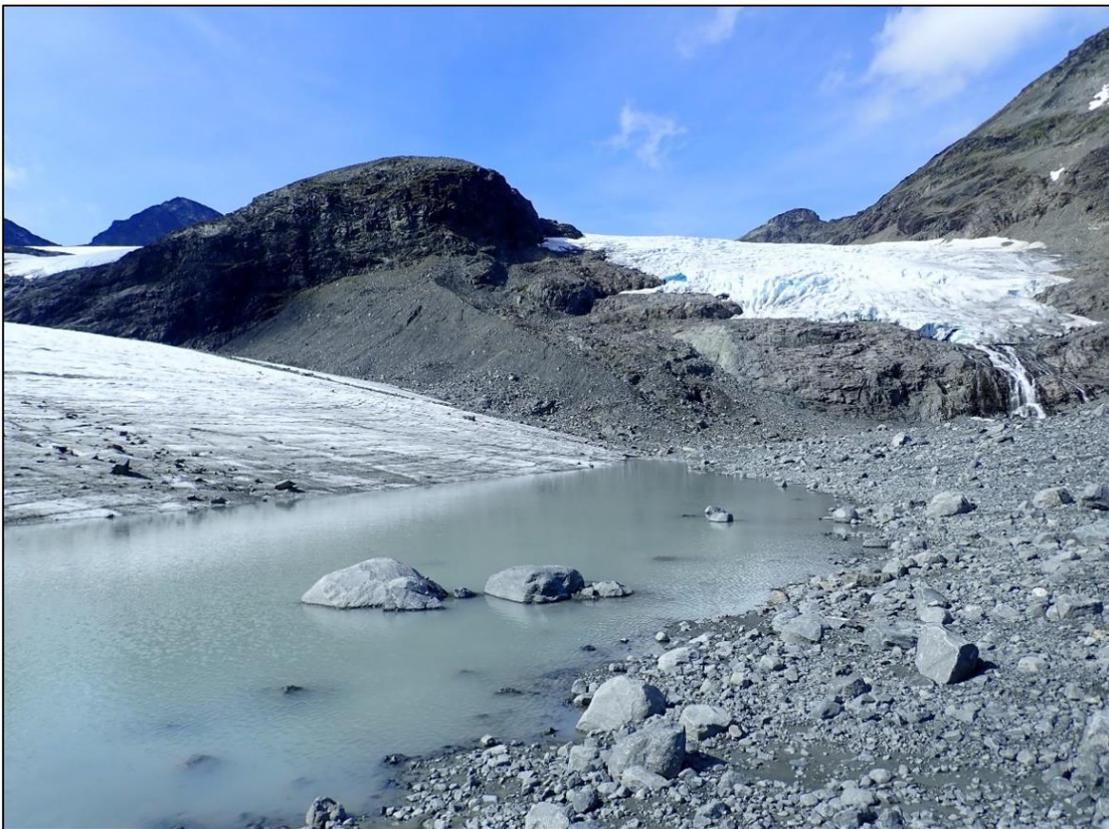
Figure 16: The lake in front of Storbreen is an example of a small glacier lake formed by glacier retreat. The size in 2018 as mapped from Sentinel-2 imagery was ca. 0.0015km^2 (1500m^2). The glacier retreated further 10-20m to 15/08/2019 when this photo was taken and where the distance across the lake was ca. 24m. The lake was categorized as a glacier lake in contact with the ice perimeter (cat. 2). Photo: Liss M. Andreassen.

Only lakes that are coupled with, or decoupled from, glacier units larger than 0.25km^2 were included in the inventory. This is to avoid inclusion of the lakes located by small ice fields, ice patches or glacier remnants, which pose little or only theoretical danger of increasing in size and emptying. In the inventory, we included all lakes larger than 0.001km^2 (1000m^2) that are within ca. 100m of the glacier perimeter. This is to ensure that the recently decoupled lakes that are still in the proximity of the glacier were also included in the inventory to be able to compare results with previous and future lake inventories. If a smaller distance is wanted for an analysis, or only lakes that are coupled with glaciers are of interest, this is easy to reselect and filter in a GIS. Lakes that are spatially smaller than 1000m^2 (10 pixels) are difficult to reliably identify in both colour image and NDWI map of the area. However, our low size limit ensures inclusion of many small glacier lakes (Figure 16). No upper limit of lake size was used.

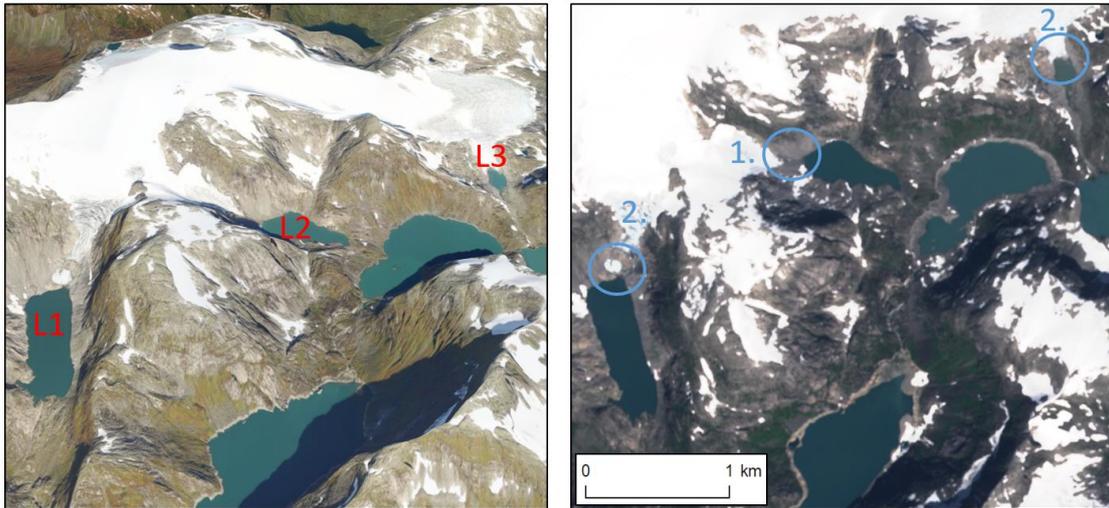
Figure 17: A 3D representation of high resolution orthoimage from 23/09/2017 over the lake subset from southern Jostefonni illustrating that the lakes L1-L3 (in red font) were neither dammed by ice nor moraine. The Sentinel-2 color image from 26/07/2018 used for the NDWI inventory calculation illustrates the coupling state of the three classified lakes in blue. The first category (decoupled) lakes are marked by 1. (in blue font) and the second category (coupled with glacier) marked by 2. (in blue font). See Figure 7 for location.

To categorize the lakes, we used: a) available orthophotos from years 2013-2018 at high 0.25-0.50m ground resolution and the DEM derived from them provided by norgebilder.no; b) the DEM for mainland Norway; c) colour Sentinel-2 imagery from given dates; d) dataset of lakes with a previous history of GLOFs in mainland Norway (Jackson and Ragulina, 2014). Out of 414 lakes, 327 lakes (ca. 79%) were found to have an interface with the glacier ice, of which 39 lakes were found to be glacier dammed. There were also two moraine dammed lakes and one supraglacial lake mapped. There may be more supraglacial lakes, however they are often too small to be identified and mapped. The final dataset contains the area and perimeter of the lakes, lake category, as well as information on the image used and data processing. As example of how lakes were categorized, lakes L1 and L3 were classified as coupled with glacier with neither ice nor moraine damming. Lake L2 was defined as decoupled from the glacier, but lying within ca. 100m from the ice perimeter at the time of mapping (Figure 17).
