Glacier lake mapping with Sentinel-2 imagery in Norway

Teodor Nagy and Liss M. Andreassen

Rapport, engelsk nr 40-2019

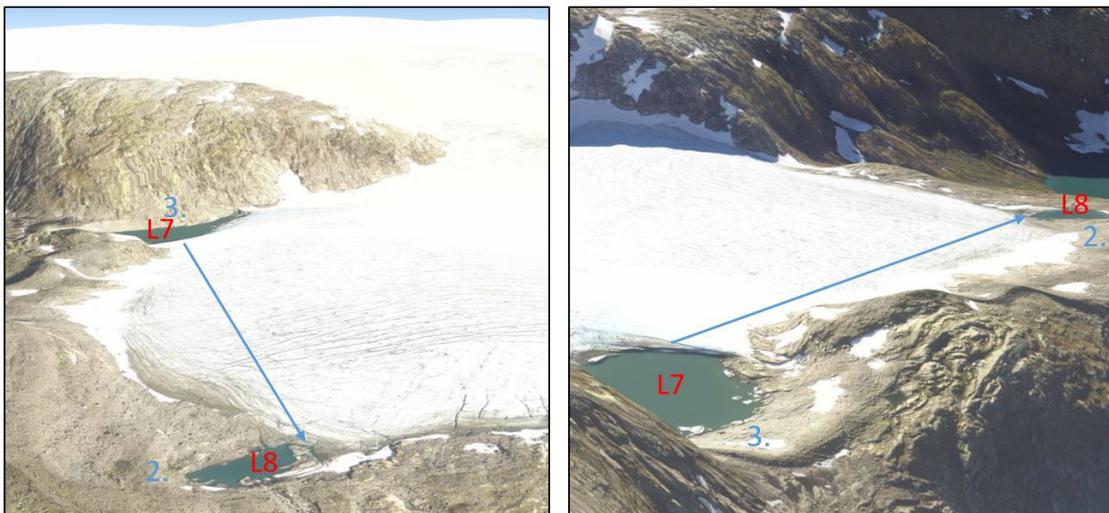
Figure 18: A 3D representation of high resolution orthophoto from 16/09/2017 showing glacier dammed lake L7, dammed by Marabreen glacier, and a likely drainage path to lake L8. Lake L7 is glacier dammed (3.) and lake L8 is a proglacial lake in contact with ice (2.). See Figure 7 for location.

An example of a glacier dammed lake is lake L7 of Marabreen, which drains to lake L8 (Figure 18).

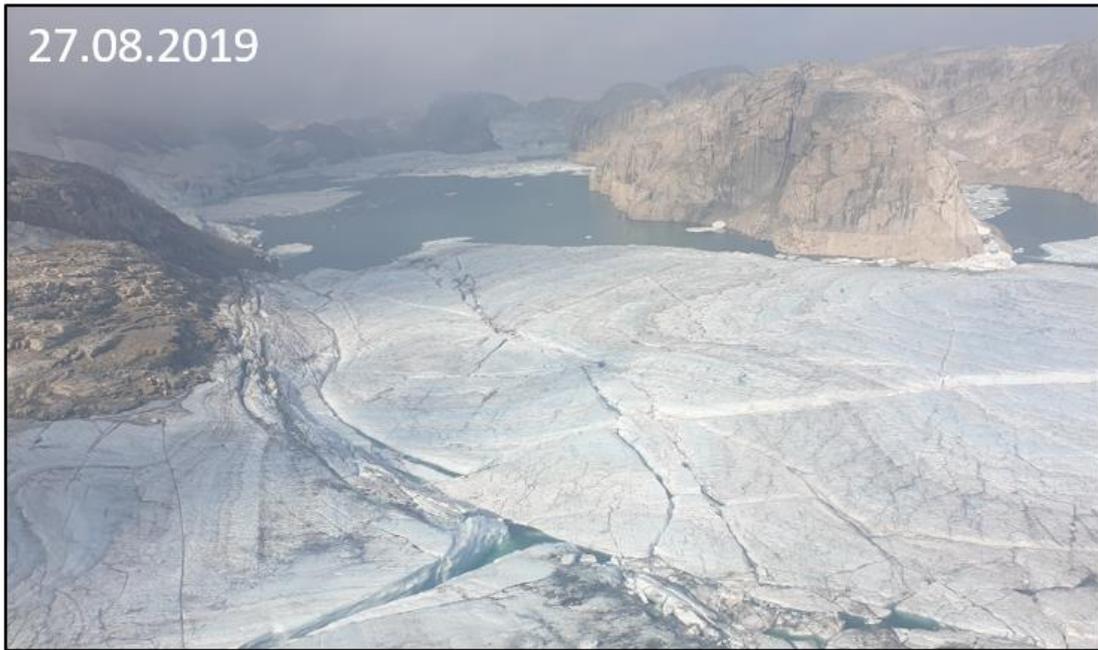
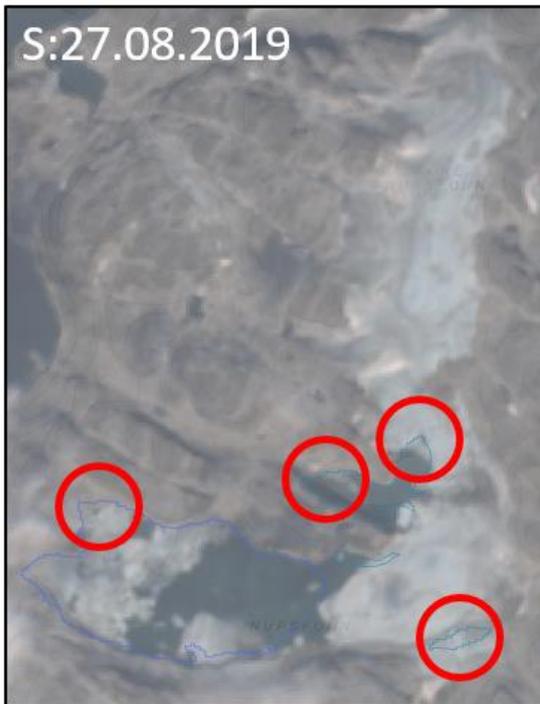
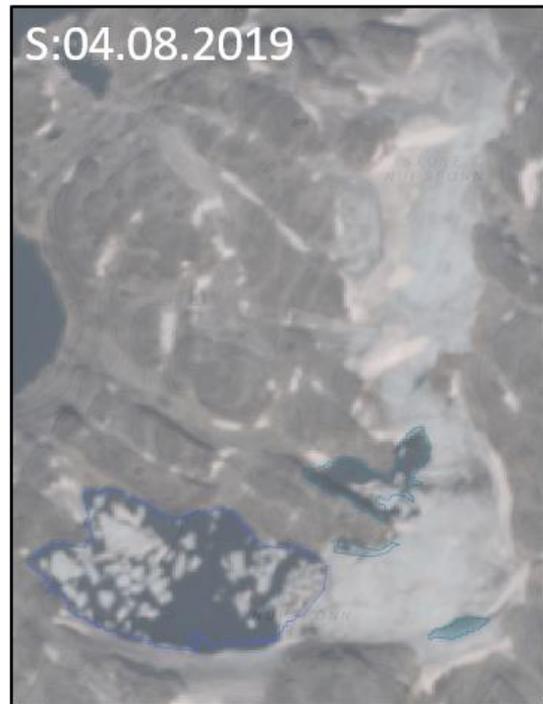
Figure 19: Upper image: Nupsfonn glacier with its glacier dammed lakes on 27/08/2019. Photo: Axel Lang Jørgensen/Statkraft. Lower imagery: Sentinel-2 imagery of Nupsfonn prior to and after the event as viewed in NVE's expert tool xGeo. Lowering of the water level can be observed in areas highlighted in red. Lake area outlines (in blue) were calculated from 2018 imagery.

A glacier with a recent event was Nupsfonn (ID 3075). This glacier had an outburst flood on 24/08/2019 with a roughly estimated drainage of 8-10mill m³ water and a ~10 m lowering of the lake (Axel Lang Jørgensen, Statkraft, personal communication, September 2019). Sentinel-2 imagery of 04/08/2019 and 27/08/2019 revealed that the two largest lakes were smaller on 27/08/2019, after the event, but had not completely emptied (Figure 19). Thus careful assessment of imagery is needed to detect events where lakes are only partially emptied.

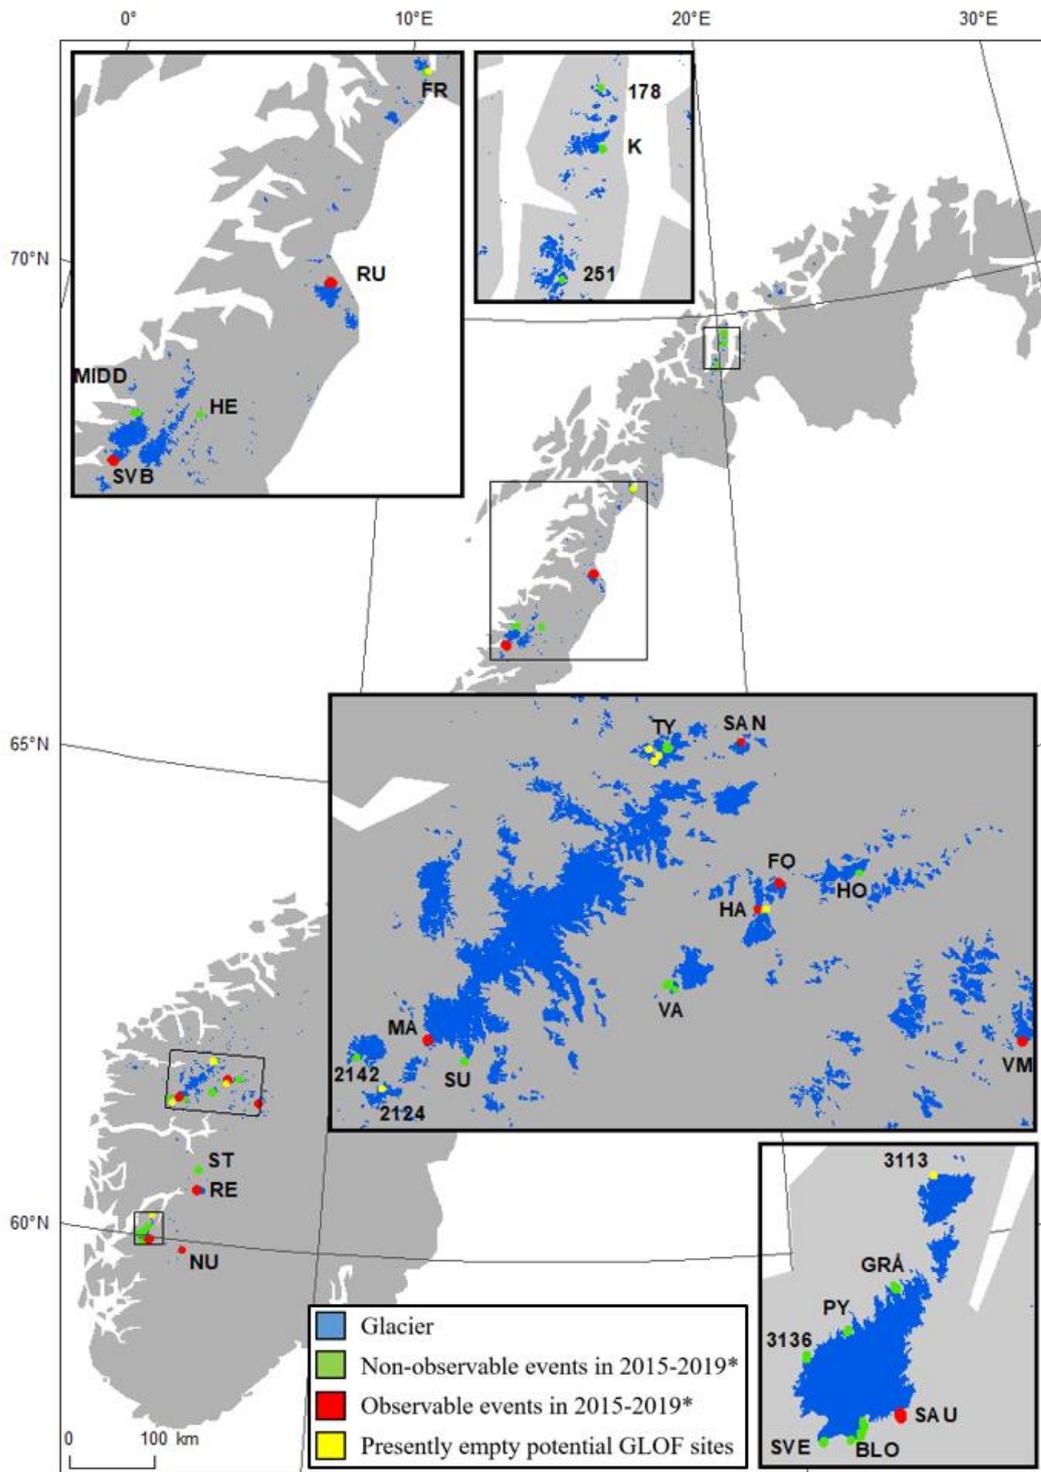
Figure 20: A map of Norway showing distribution of identified glacier and moraine dammed lakes in the present glacier lake inventory. Seven additional presently empty sites, where filling up is considered possible, are also identified. For abbreviations see Table 5. Green: No observable emptying was recorded in the period 2015-2019*. Red: At least one observable event was recorded in the period 2015-2019*. Yellow: No water body was detected but there is a potential for filling up of the space with water. *Last image of observation was 23/07/2019 (later imagery from 2019 was used for Nupsfonn, Rembedalskåka, and Rundvassbreen).

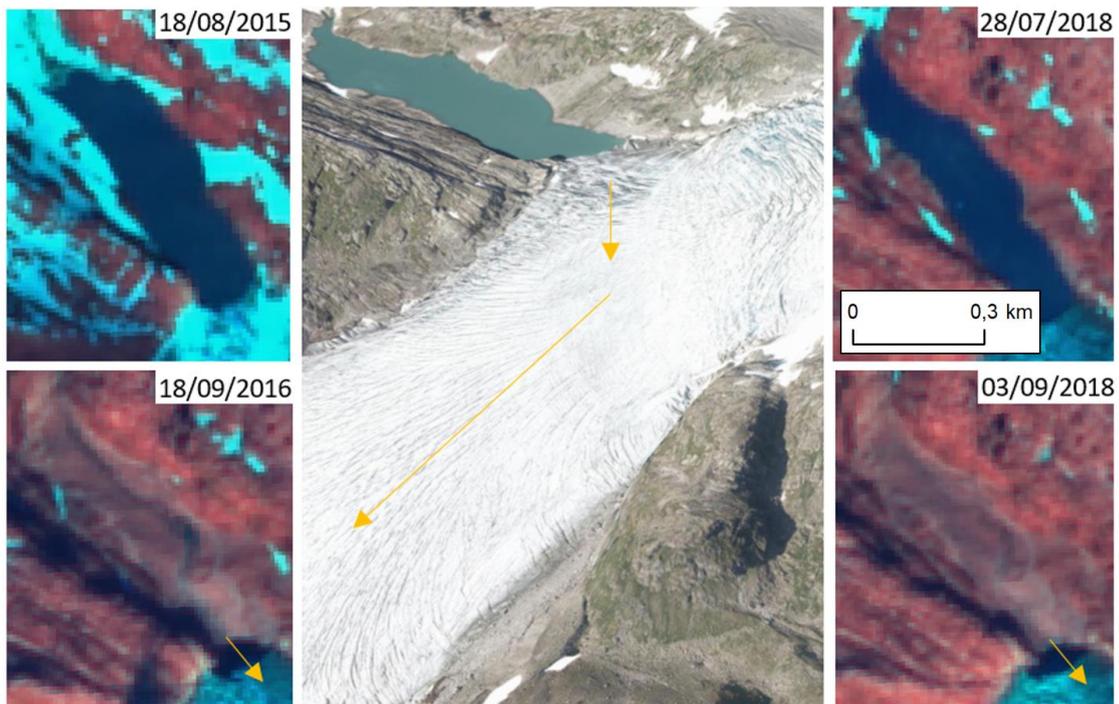
Figure 21: GLOF events (jökulhlaups) of Nedre Demmevatnet in 2016 and 2018. A pre and post-event Sentinel-2 false colour imagery is shown together with a 3D representation of an orthophoto from 20/07/2013. Yellow arrow approximates the likely drainage path. See Figure 1 for location.

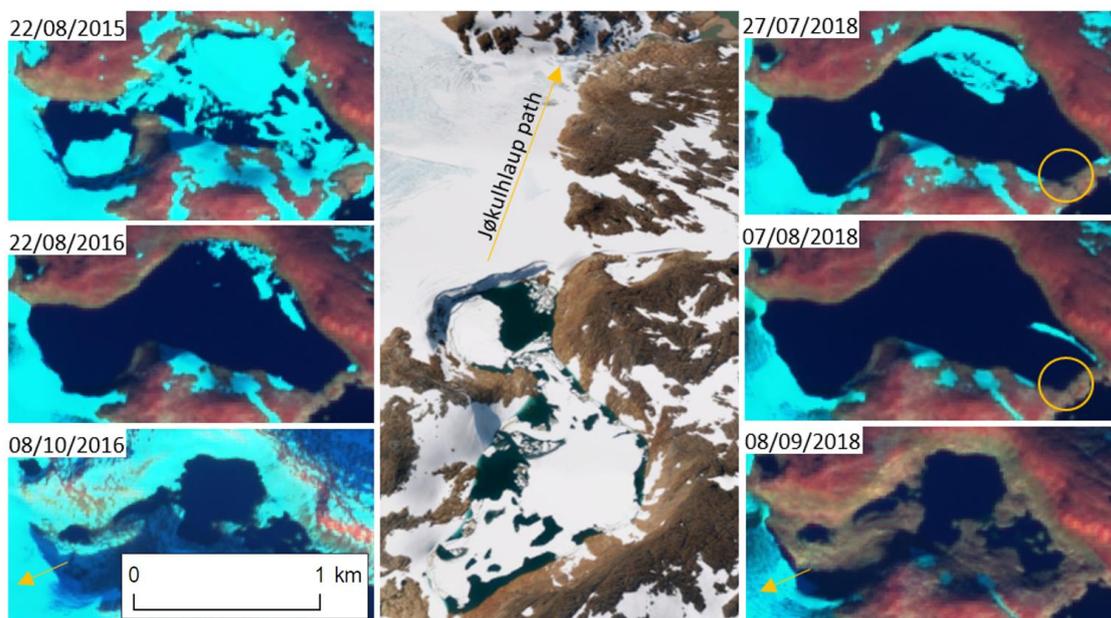
Figure 22: GLOF events (jökulhlaups) of Øvre Messingmalvatn represented by Sentinel-2 false colour imagery and a 3D representation of an ortophoto from 16/08/2015. Yellow arrow approximates the likely drainage path. Lake filling in the 10 day period 27/07/2018-07/08/2018 is illustrated by the yellow circle. See Figure 1 for location.

The emptying of Øvre Messingmalvatn was recorded by SISO Energi and was estimated to have started on 25/08/2018. The closest pre and post event imagery with partly distinguishable lake outlines came from 14/08/2018 and 26/08/2018 respectively. Thus, glacier lake emptying can be observed from Sentinel-2 imagery, but whether there is good imagery available close to time of the event depends mainly on the cloud cover. Many GLOF events occur in late summer, when clouds are persistent, and Sentinel-2 imagery may give little or no information. Sentinel-1 imagery can be a good supplementary source that can be used to provide more information on timing of glacier lake emptying.

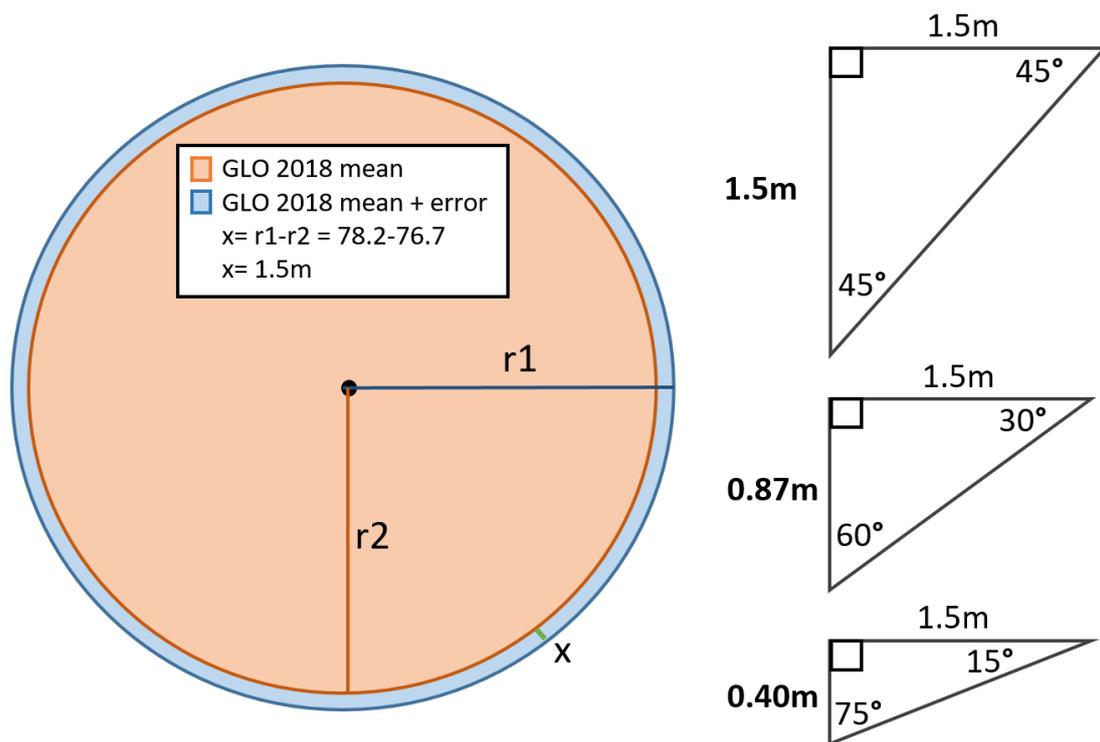
Figure 23: Theoretical approximation of a difference between a mean size inventory lake with radius r2 and a mean size inventory lake with estimated inventory inaccuracy of 4% with radius r1. Three triangles show the lake level fluctuation (in bold) for 15, 30 and 45 degree sloping lakes that cannot be observed with confidence using an inaccuracy of 4%. Figure is an approximation.

To calculate the theoretical minimum lake surface fluctuation that can be observable with some degree of confidence, a median size inventory lake of 0.0185km² can be approximated as a circle with radius r2. Assuming a 4% inaccuracy in the inventory, the difference between the second circle with radius r1 representing a median size inventory lake with an additional error of ±4% of 0.0192km² area is found to be ca. 1.5m (Figure 23). Using the 1.5m horizontal distance, the minimum lake water level decrease or increase that can be observed for the lake slopes of 45, 30 and 15 degrees is 1.5, 0.87 and 0.40m respectively. Using the calculated area of Nedre Demmevatnet from 28/07/2018, and assuming the average lake sloping of 15 degrees, the minimum water filling up of ca. 57000m³ would need to occur for the filling up to be theoretically observable. This represents ca. 3% of the maximum lake volume, based on the estimated water volume 1.85mill m³ from the 2016 emptying event.

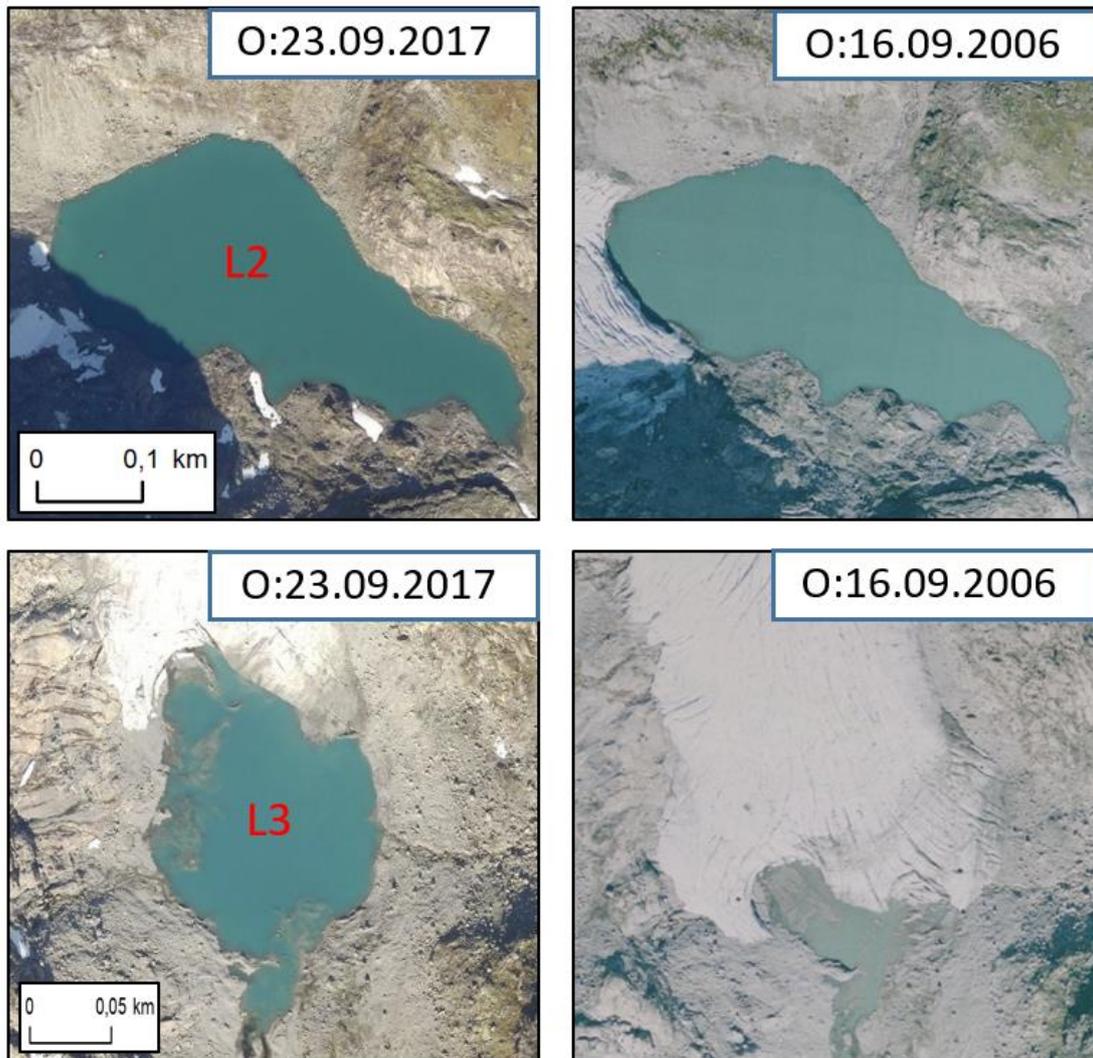
Figure 24: Illustration of lake area change categorization using high resolution orthoimagery from norgebilder.no over the lake subset from southern Jostefonni. Upper photos show lake L2 that appears to have stayed constant despite glacier retreat and is categorized as (2): Lake area appears to have stayed unchanged. Lower photos show lake L3 has increased due to glacier retreat and was categorized as (1): Lake area has increased. See Figure 7 for location.

In total, 163 lakes were found to have increased in size, and 46 lakes were found to have stayed unchanged (Figure 24). Further 83 new lakes were found to have formed. There were three regulated lakes mapped in our inventory, such as Styggevatnet (Figure 25). The size change of 119 lakes could not be determined, e.g. due to lake ice or snow cover (Figure 25) The glacier lakes that were classified as glacier dammed and with a history of GLOFs were also categorized as not possible to provide observable change (category 3). This is due to periodic filling and emptying of the lakes.

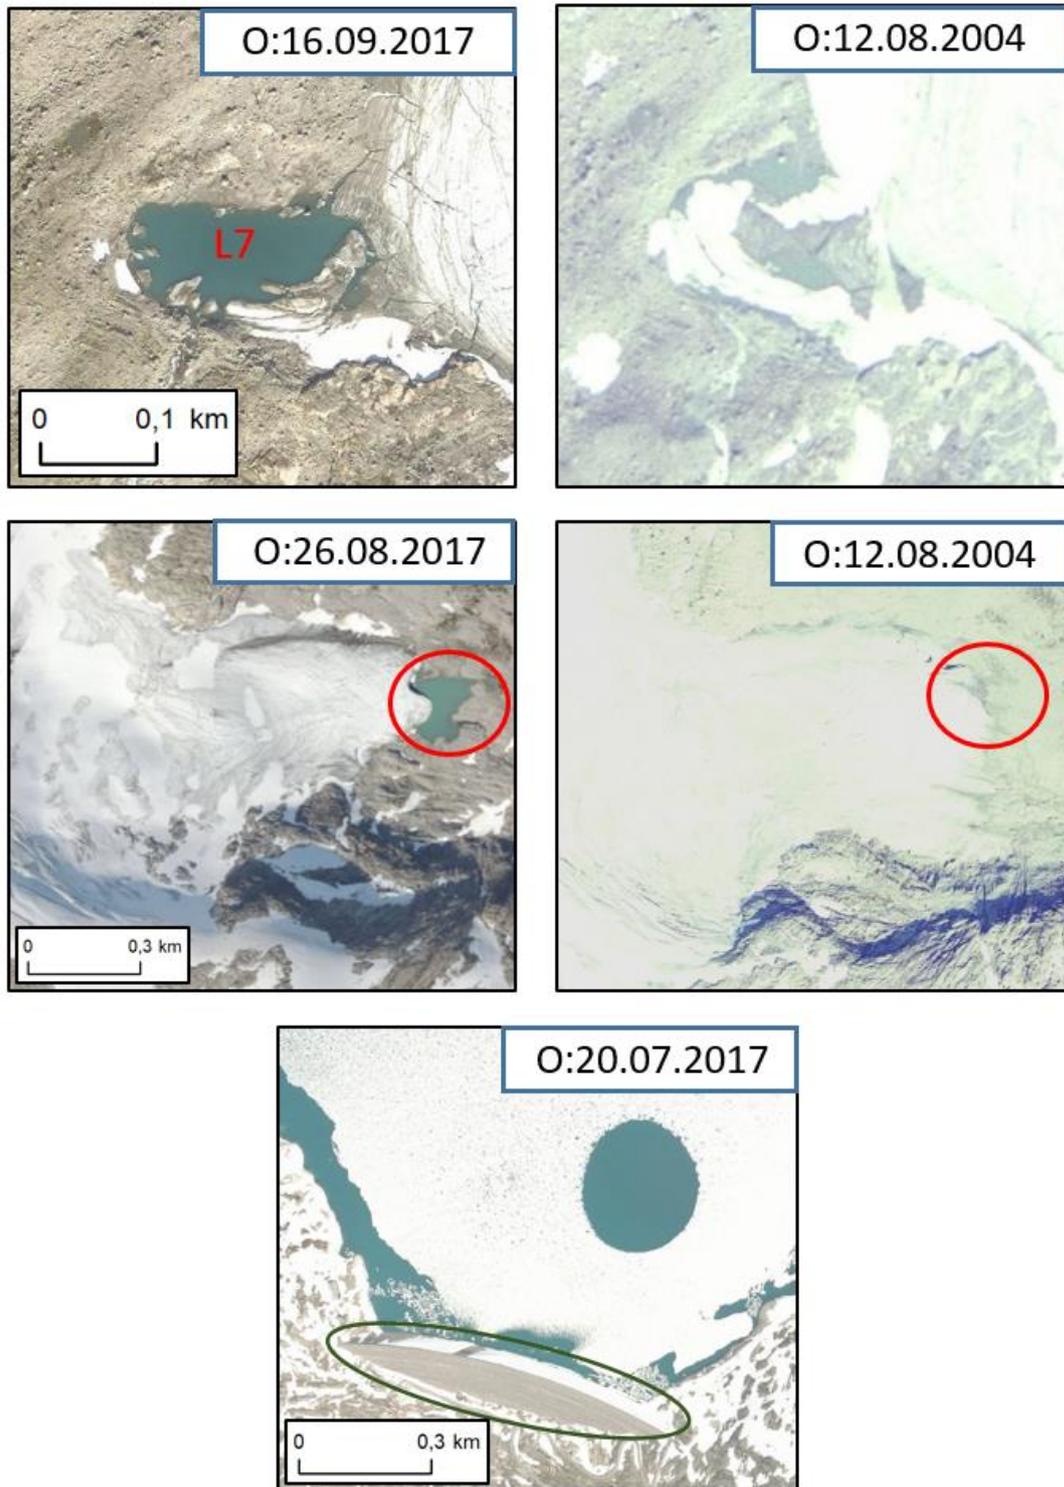
Figure 25: Illustration of lake area change categorization using high resolution orthoimagery from norgebilder.no. Upper photos: show Lake L7 (dammed by Marabreen glacier) that was categorized as (3): Lake area change cannot be determined. Mid row photos show glacier (ID 2345) with lake in red circle that was categorized as (4): New lake, no lake observed previously. Lower photo shows Styggevatnet in front of Austdalsbreen that is an artificially regulated water body with the dam structure highlighted in green. Lake was categorized as (5): Regulated lake, fluctuates artificially. See Figure 7 and Figure 1 for location.

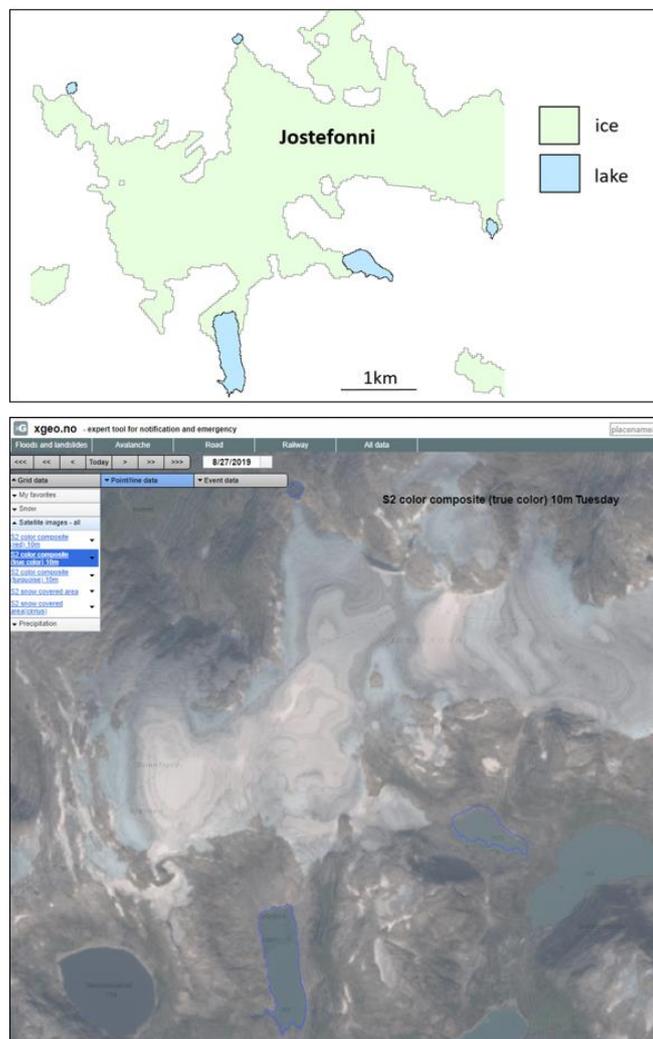
Figure 26: Upper figure shows the downloadable glacier lake outline product featuring lakes L1-L5 by Jostefonni glacier from test region 1 (See Figure 1). Glacier outline is from Andreassen et al. (2012). Lower figure shows the glacier lake outlines (in blue) displayed on a background Sentinel-2 image from 27/08/2019 as visualized in xGeo.
